Dodd Boulevard at Lake Marion Greenway Trail

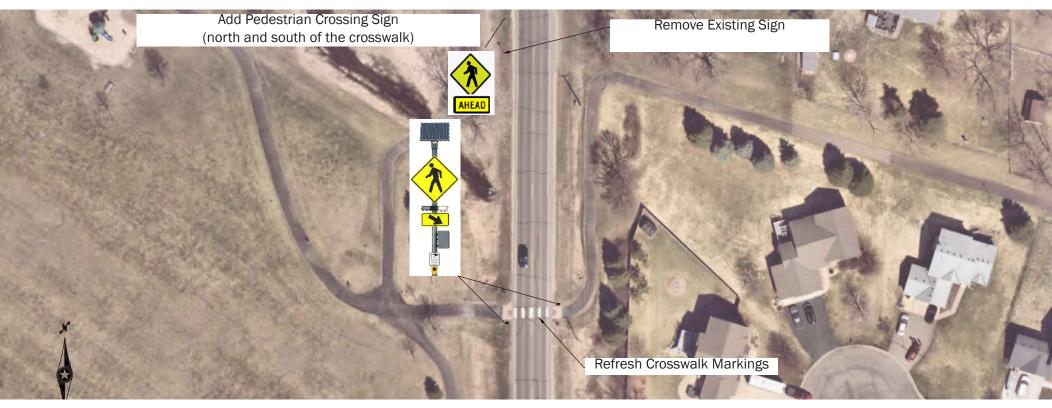
Low yield compliance for people crossing Dodd Boulevard at the existing marked crosswalk.

- Rectangular Rapid Flashing Beacons (RRFBs)
- Advanced pedestrian crossing signage
- Refresh crosswalk markings
