Landfill Host Community

Environmental Legacy Fund (ELF) Grant

Report of Inspection Procedures and Results for
Determining Qualifications of a
Tax Increment Financing District as a Redevelopment District

Rosemount KenRose TIF District Rosemount, Minnesota

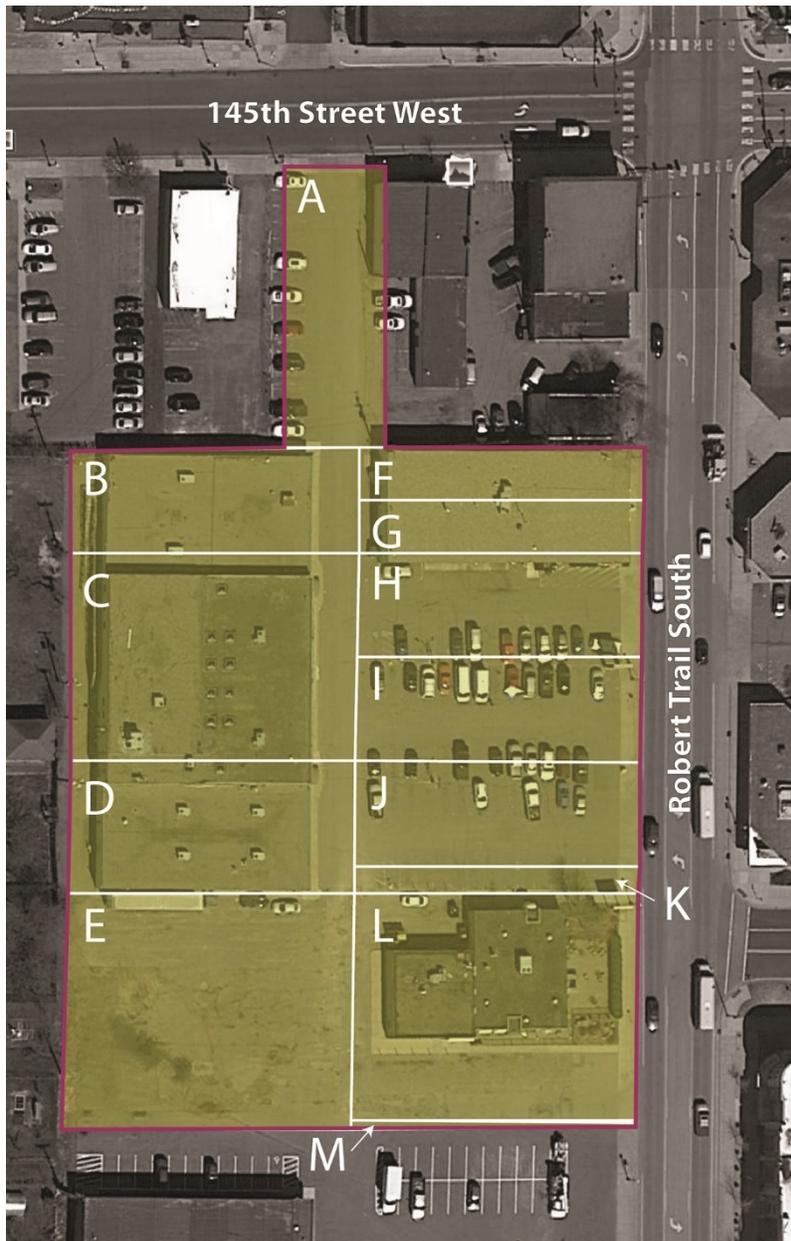
Diagram 1 – Proposed TIF District

LHB was hired by the City of Rosemount to inspect and evaluate the properties within a Tax Increment Financing Redevelopment District (“TIF District”) proposed to be established by the City. The proposed TIF District is located at the southwest corner of 145th Street West and Robert Trail South (Diagram 1). The purpose of LHB’s work is to determine whether the proposed TIF District meets the statutory requirements for coverage, and whether three (3) buildings on thirteen (13) parcels, located within the proposed TIF District, meet the qualifications required for a Redevelopment District.

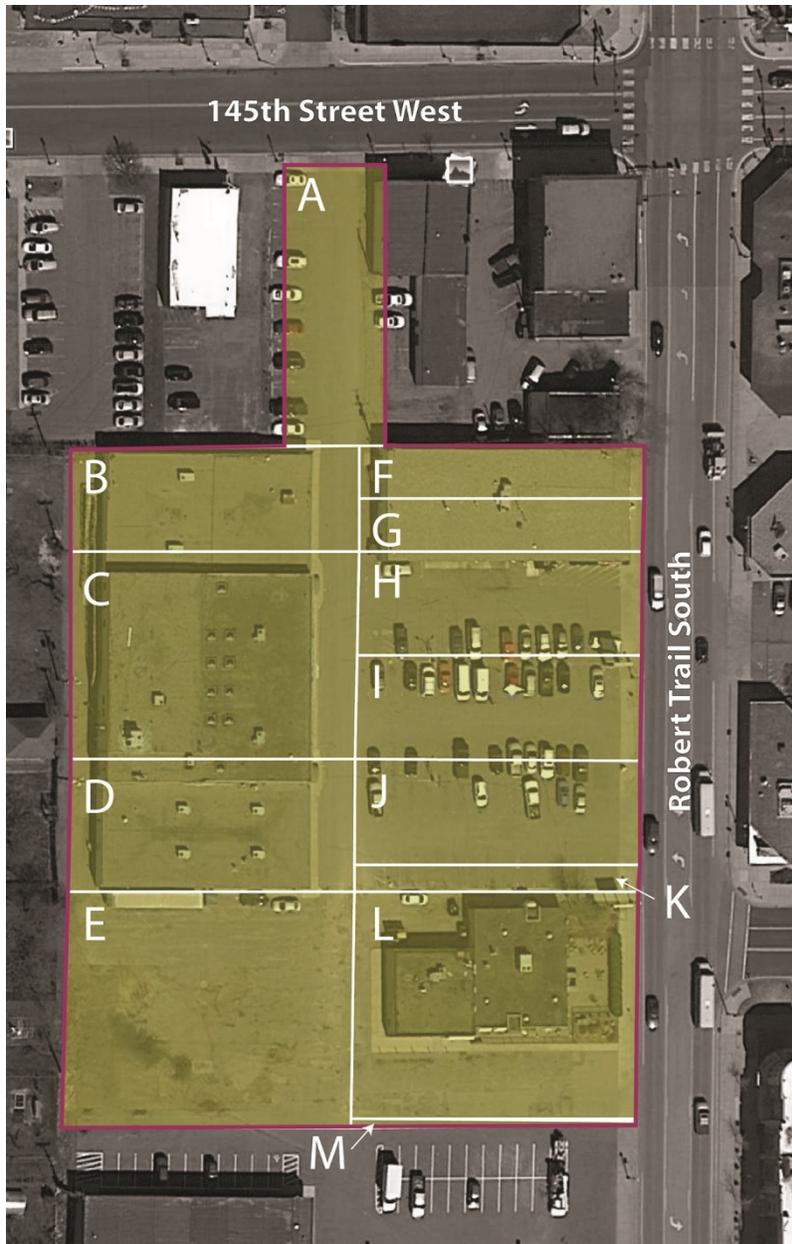
Diagram 2 – Coverage Diagram

The proposed TIF District met the coverage test under *Minnesota Statutes, Section 469.174, Subdivision 10(e)*, which resulted in parcels consisting of 100 percent of the area of the proposed TIF District being occupied by buildings, streets, utilities, paved or gravel parking lots, or other similar structures (Diagram 2). This exceeds the 70 percent area coverage requirement for the proposed TIF District under *Minnesota Statutes, Section 469.174, Subdivision (a) (1)*.

Shaded area depicts a parcel more than 15 percent occupied by buildings, streets, utilities, paved or gravel parking lots or other similar structures

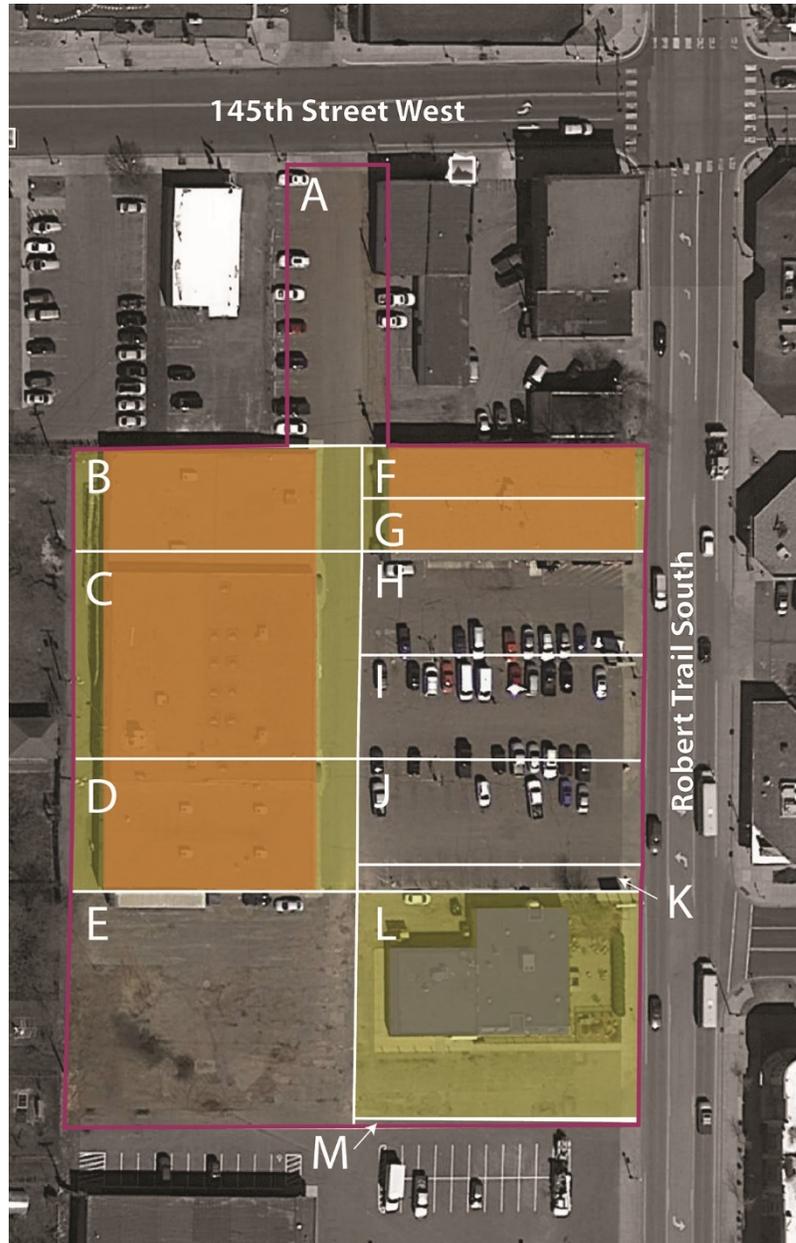
Diagram 3 – Substandard Buildings
Shaded green area depicts parcels with buildings.
Shaded orange area depicts substandard buildings.

The parcels with substandard buildings are reasonably distributed compared to all parcels that contain buildings.
