# Lebanon Hills Regional Park Subwatershed Assessment Report

*Prepared for:*  
Dakota County Parks Department  
Dakota County Environmental Services

**WENCK Associates, Inc.**  
7500 Olson Memorial Highway  
Suite 300  
Golden Valley, MN 55427  
Phone: 763-252-6800

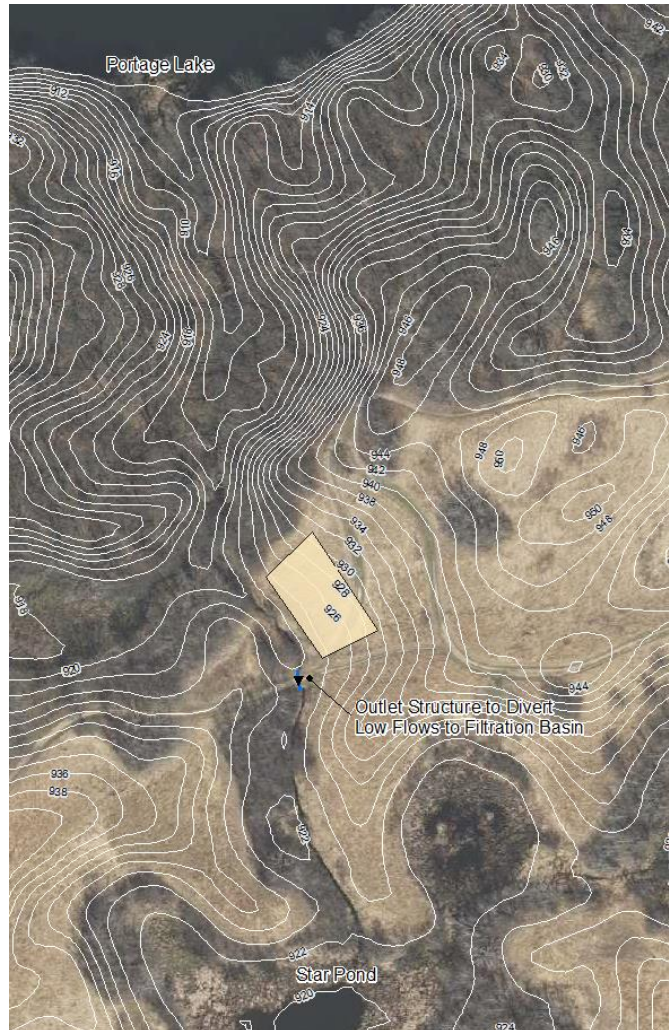
The REG-1 BMP is a surface filtration basin located adjacent to the outlet channel of Star Pond (Watershed ID LP-66) which is upstream of Schulze and Portage Lakes. The contributing watershed is approximately 619 acres with primarily undeveloped and low density residential land use. P8 modeling results indicate the estimated annual TP load is 28.9 lbs with a high dissolved phosphorus fraction. Due to the high dissolved phosphorus fraction, it is proposed that the filtration basin media be iron enhanced sand which can remove the dissolved phosphorus. The iron enhanced sand filtration (IESF) area was sized to treat runoff from the 1.1-inch storm event and is estimated to reduce TP loads by approximately 16.1 lbs per year. The project includes earthwork, IESF basin (approximately 9,300 sf), berm and outlet structure, and site restoration. The estimated construction cost is approximately \$425,000. The 30-year life cycle cost estimate is approximately \$1,245,000. The 30-year cost-benefit is \$2,578/lb TP removed.

Concept overview of proposed filtration basin location and approximate sizes.

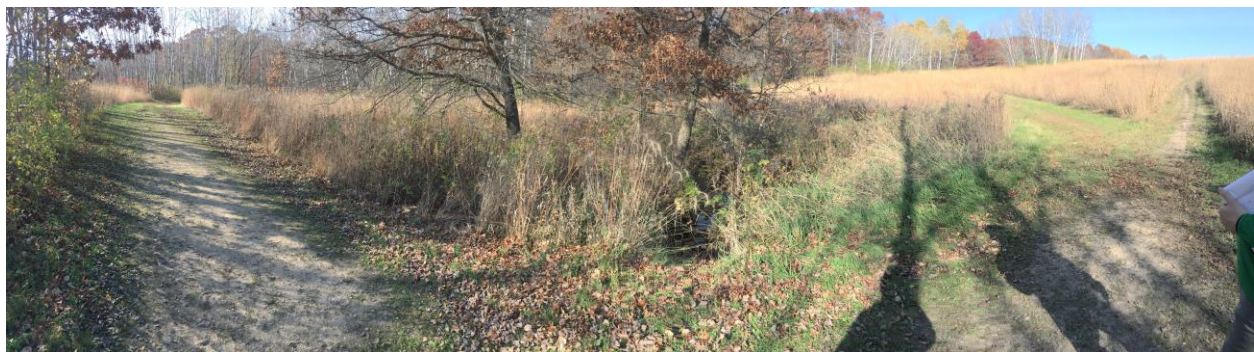
Photo of project site looking downstream. The channel is located between the trees in the middle of photo. The filtration basin is proposed where the grassy area is on the right side of the photo.

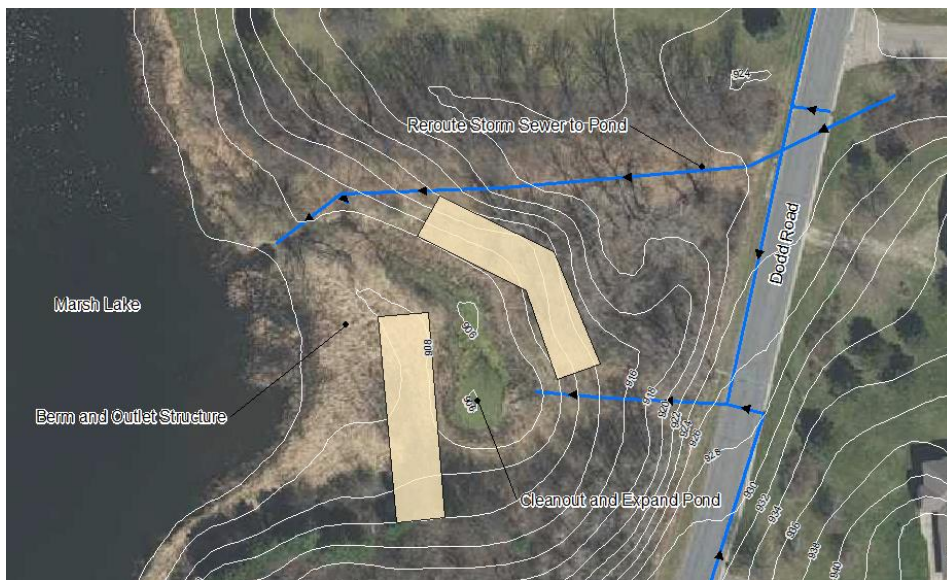
REG-2 (McDonough/Marsh Lake)

The REG-2 BMP includes two surface filtration benches retrofitted to an existing pond (Watershed ID LP-22.2) at the shoreline of Marsh Lake. The contributing watershed is approximately 303 acres with residential and commercial land use. The P8 model indicates the annual TP load out of this pond is 27.9 lbs with a high dissolved phosphorus fraction. Due to the high dissolved phosphorus fraction, it is proposed that the filtration bench media be iron enhanced sand. The IESF benches were sized to treat runoff from the 1.1-inch storm event and is estimated to reduce TP loads by 16.4 lbs per year. The project includes rerouting storm sewer from LP-22.1 to the pond, two IESF benches (approximately 9,100 sf total), pond cleanout and expansion, berm and outlet structure, and site restoration. The estimated construction cost is approximately \$645,000. The 30-year life cycle cost estimate is approximately \$1,585,000. The 30-year cost-benefit is \$3,222/lb TP removed.

Concept overview of proposed filter bench locations (tan rectangle) and approximate sizes. Blue lines indicate existing storm sewer infrastructure.

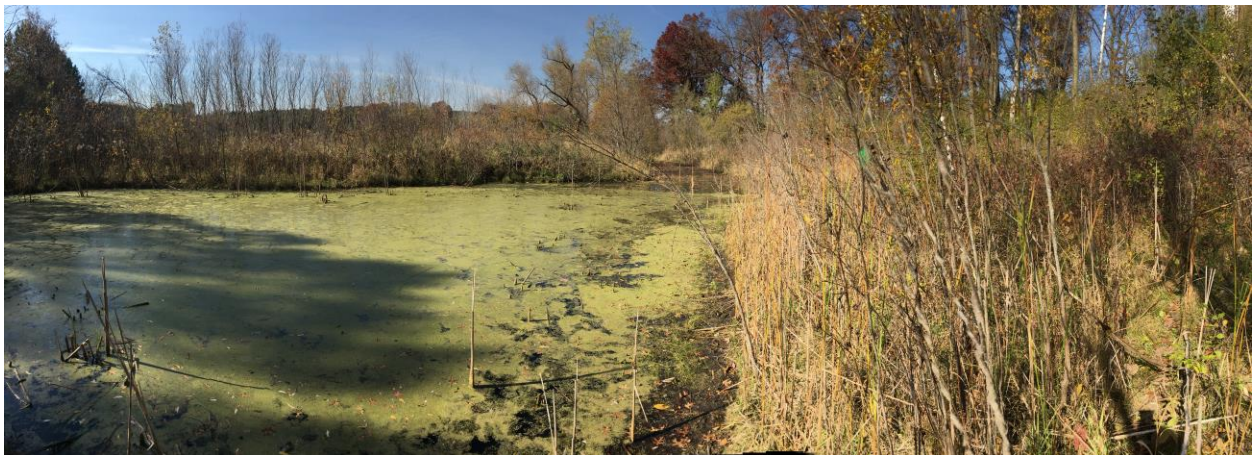
Photo from the southeast corner of the existing pond. Filter benches are proposed on both sides of the pond.

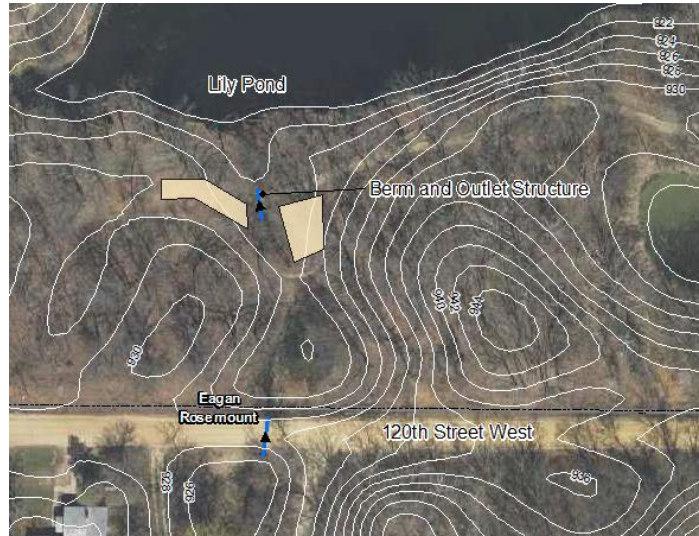
REG-3 (O'Brien Lake/Lily Pond)

The REG-3 BMP includes two surface filtration basins located adjacent to the outlet channel of LP-15.1 at the shoreline of Lily Pond which is upstream of O'Brien lake. The contributing watershed is approximately 144 acres of primarily undeveloped and low density residential land use. The P8 model estimates that this channel delivers approximately 7.3 pounds of TP/year to Lily Pond with a high dissolved phosphorus fraction. Therefore, it is proposed that the sand filtration areas be enhanced with iron and sized to treat runoff from the 1.1-inch storm event and is estimated to reduce TP loads by 4.1 lbs per year. The project includes earthwork, two IESF areas (approximately 2,700 sf total), berm and outlet structure, and site restoration. There is not a significant amount of elevation difference at this location which will be a challenge in the design and implementation of the proposed filter. The estimated construction cost is approximately \$190,000. The 30-year life cycle cost estimate is approximately \$530,000. The 30-year cost-benefit is \$4,309/lb TP removed.

Concept overview of proposed filtration basin locations and approximate sizes.

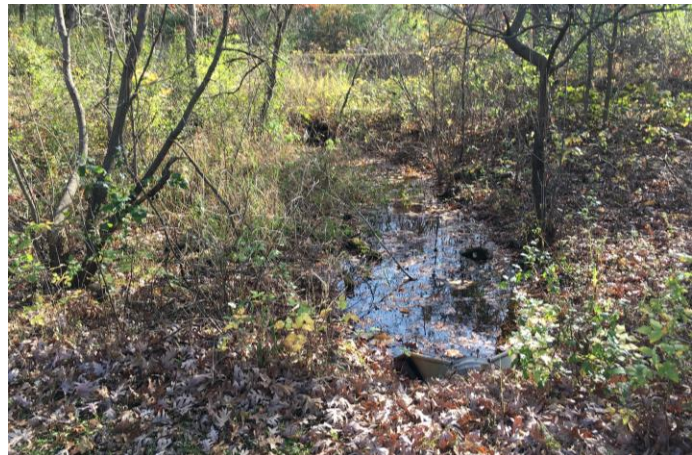
The existing channel looking upstream. Filtration basins are proposed on both the east and west side of the channel.

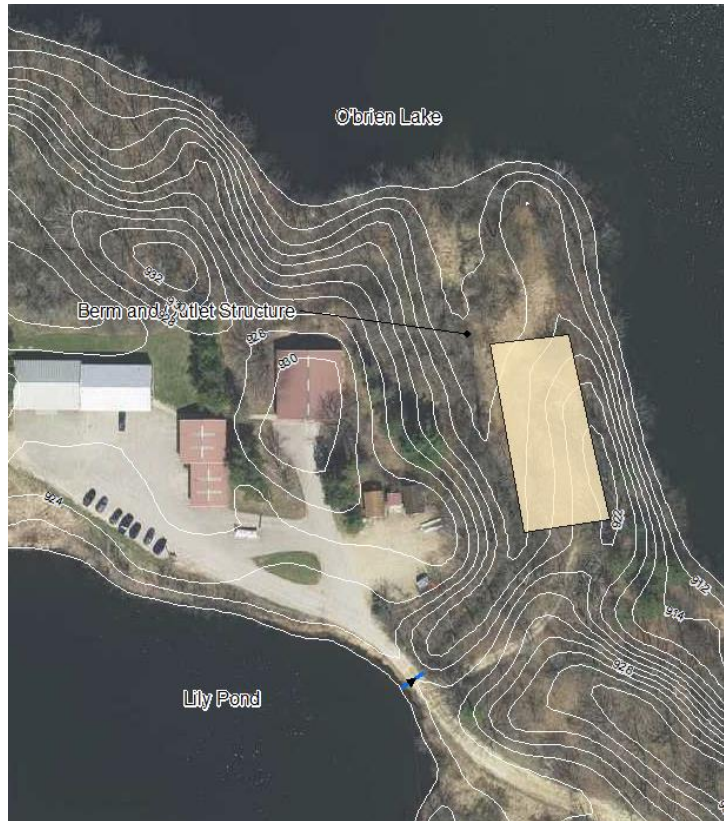
The REG-4 BMP is a surface filtration basin located adjacent to the outlet channel of Lily Pond directly upstream of O'Brien Lake. The contributing watershed is approximately 649 acres which includes a mixture of land use. The in-lake response modeling for Lily Pond estimates an annual TP outflow load of 9.0 lbs with a low dissolved phosphorus fraction. Due to the low dissolved phosphorus fraction, a sand filter without iron is proposed. The sand filter was sized to treat runoff from the 0.75-inch storm event and is estimated to reduce TP loads by 5.5 lbs per year. The project includes earthwork, a sand filtration basin (approximately 13,700 sf), berm and outlet structure, and site restoration. The estimated construction cost is approximately \$415,000. The 30-year life cycle cost estimate is approximately \$760,000. The 30-year cost-benefit is \$4,606/lb TP removed.

Concept overview of proposed filtration basin location and approximate size.

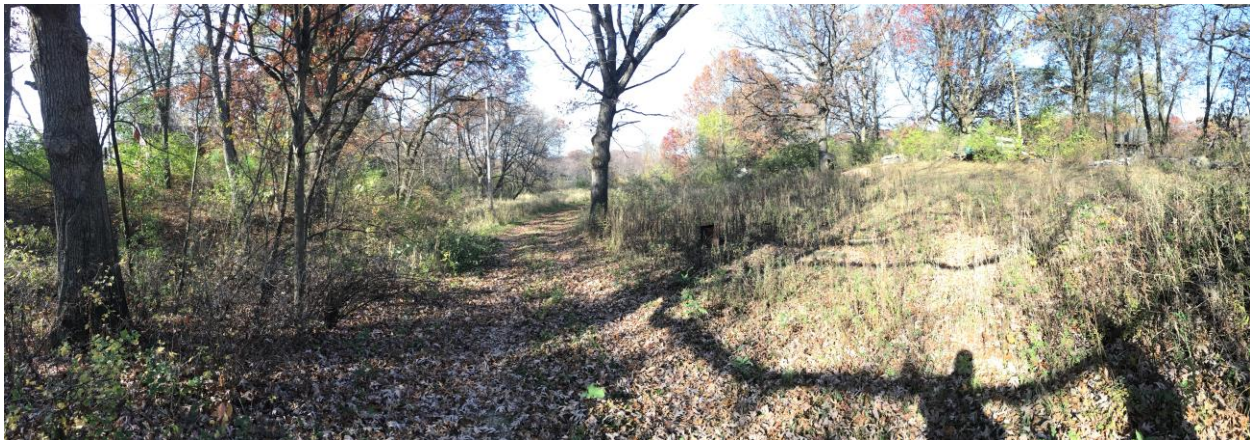
Photo of project site looking downstream. The channel is located within the trees along the left side of the photo. The filtration basin is proposed to the right of the channel in the open area to where the hill is located.

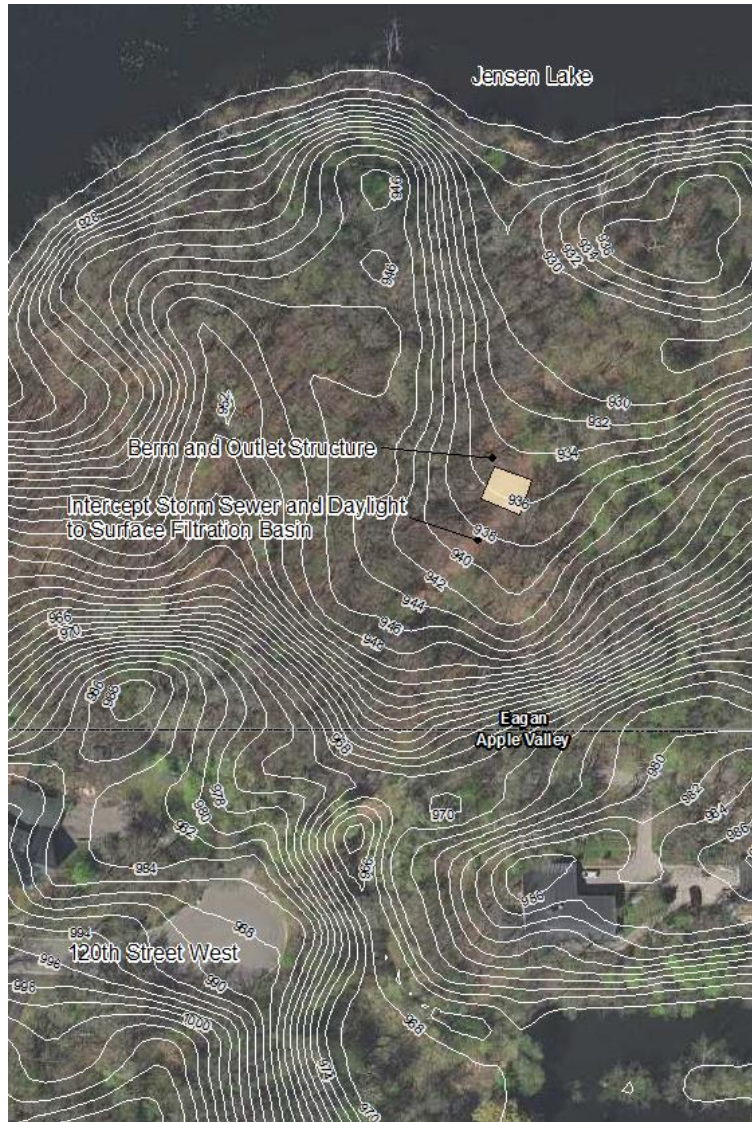
The REG-5 BMP is a surface filtration basin located in a wooded area downstream of LP-11 prior to discharging to Jensen Lake. The contributing watershed is approximately 77 acres consisting of residential land use and a golf course. The P8 estimated annual TP load for this site is 3.2 lbs with a high dissolved phosphorus fraction. Due to the high dissolved phosphorus fraction, an IESF is proposed and sized to treat runoff from the 1.1-inch storm event. This project would reduce TP loads to Jensen Lake by approximately 1.8 lbs per year. The project includes earthwork, IESF basin (approximately 1,000 sf), berm and outlet structure, and site restoration. At the proposed location, stormwater is conveyed in a pipe which would need to be intercepted and diverted to the surface for the proposed surface filtration basin. A below grade filter could be installed, however, the cost would increase and monitoring and maintenance may be more challenging. The estimated construction cost is approximately \$165,000. The 30-year life cycle cost estimate is approximately \$360,000. The 30-year cost-benefit is \$6,667/lb TP removed.

Concept overview of proposed filtration basin location and approximate size.

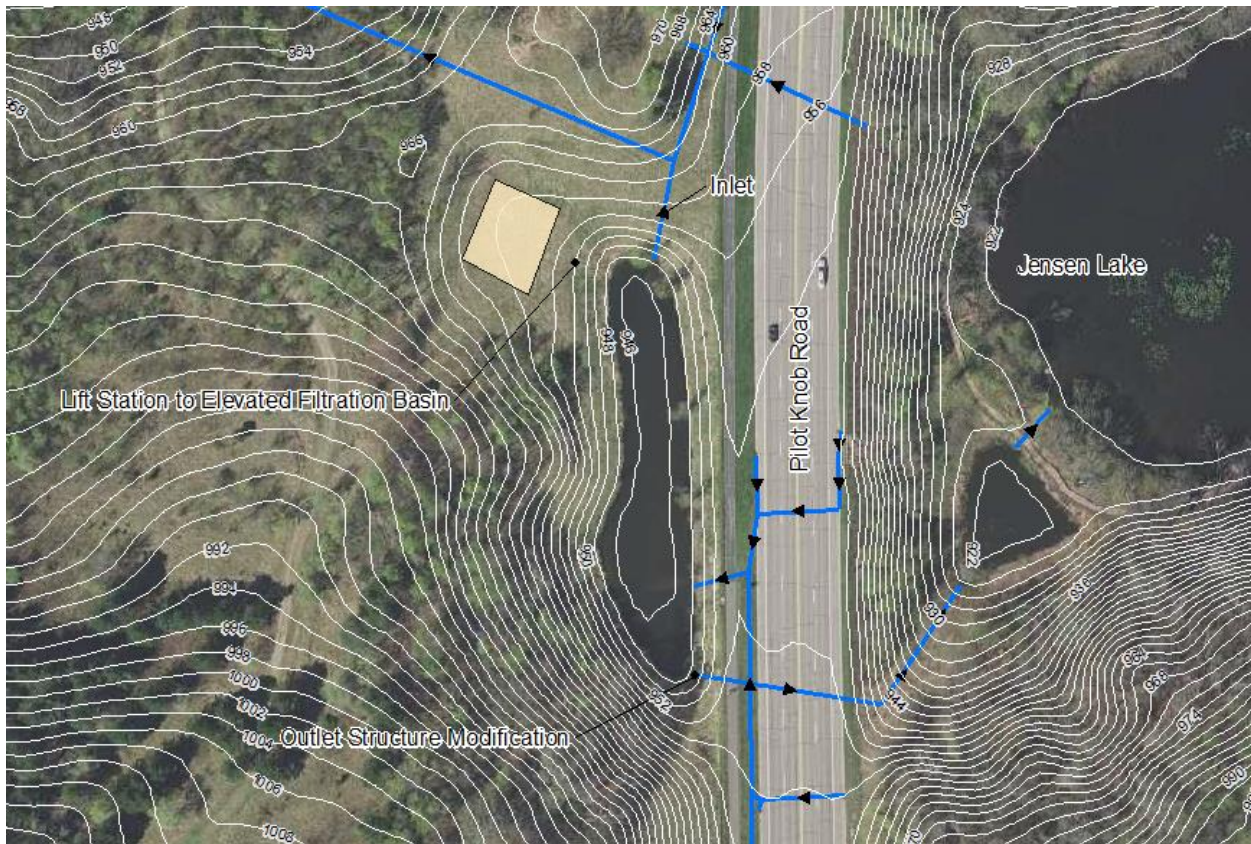
The REG-6 BMP is a surface filtration bench retrofitted to an existing stormwater pond in the Jensen Lake subwatershed. Based on site constraints, the filtration area will likely need to be elevated above the pond and require a lift station to pump stormwater from the pond to the filtration area. The contributing watershed is approximately 134 acres with residential and highway land use. The P8 model estimated annual TP load is 10.1 lbs with a high dissolved phosphorus fraction. Due to the high dissolved phosphorus fraction, an IESF is proposed and sized to treat runoff from the 1.1-inch storm event. This project would reduce TP loads to Jensen Lake by approximately 5.8 lbs per year. The project includes earthwork, lift station, IESF basin (approximately 3,500 sf), berm, outlet structure modifications, and site restoration. The estimated construction cost is approximately \$600,000. The 30-year life cycle cost estimate is approximately \$1,035,000. The 30-year cost-benefit is \$5,948/lb TP removed.

Concept overview of proposed filter bench location and approximate size.

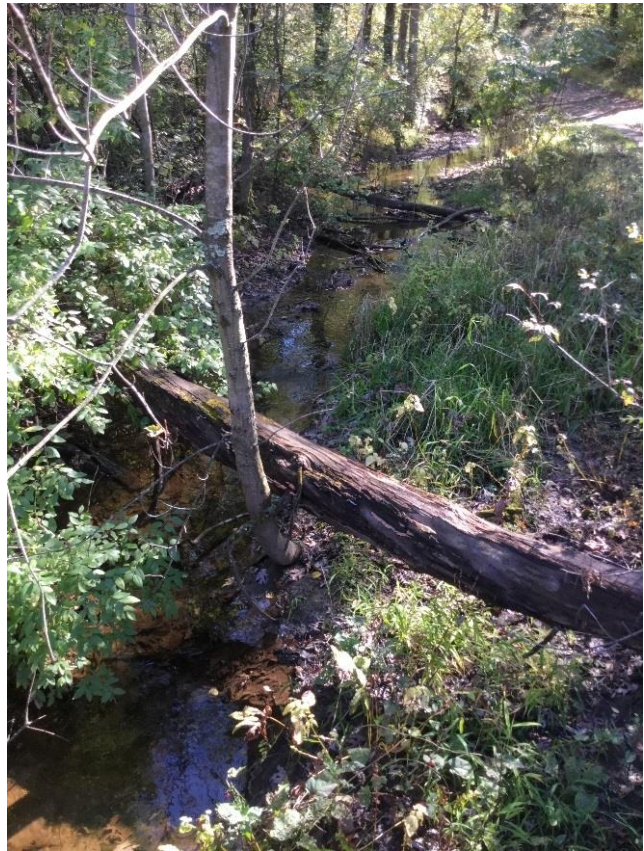
### 1M/4M (McDonough Lake)

Example of a tree that has fallen across the channel. When this tree decomposes and falls into the channel, it could redirect flow into the bank and create a scour.

Location 1M/4M is a trail crossing a channel connecting Wood Pond to McDonough Lake. The channel is wider closer to Wood Pond (4 feet wide, 3 feet tall), and becomes narrower as you approach McDonough Lake (2 feet wide, 1 foot tall). The channel is approximately 800 feet long from Wood Pond to the gravel trail culvert near McDonough (18" PVC corrugated) then approximately 180 feet from the culvert to McDonough Lake. Some erosion may be occurring at the trail crossing, where culverts may be undersized for creek flows. Otherwise, the channel is mostly stable with organic sand/silt in the stream bottom and woody debris scattered throughout providing habitat opportunities for aquatic and terrestrial organisms. Ongoing observation and maintenance of this channel should include clearing tree deadfalls that might obstruct flow in the channel or redirect flow into the bank and start an erosion scour. Trail maintenance should be done to correctly size and install an appropriate culvert. The estimated park maintenance cost for this site is approximately \$33,000 and includes tree thinning, culvert removal and replacement, and general trail maintenance/repairs. A detailed cost estimate table for this site is included in Appendix F.

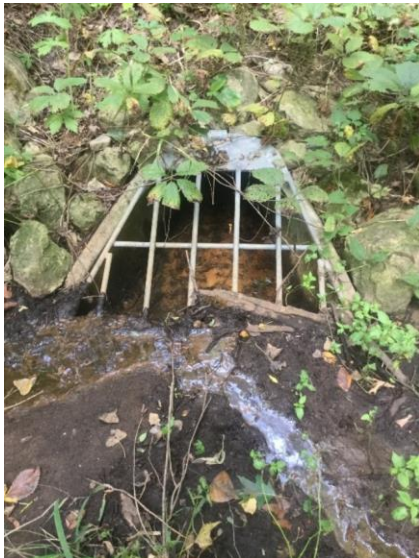
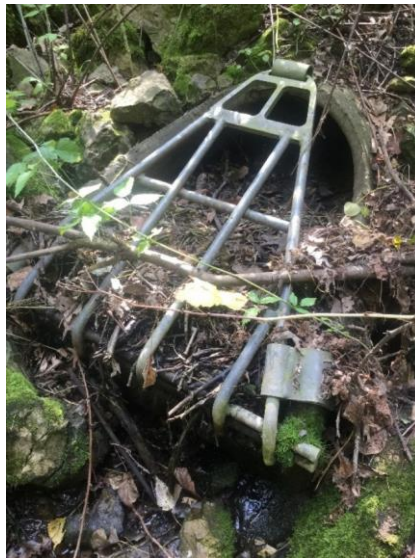
Sediment accumulation on upstream end (left photo) of the culvert should be cleaned out to prevent remobilization. Outlet of existing culvert (right photo) should be cleaned out and additional riprap placed to prevent undercutting of the structure.

Location 3J is a trail crossing a drainage swale receiving drainage from Valleywood Golf Course and an adjacent cul-de-sac that flows into a Reinforced Concrete Pipe (RCP) and is piped directly to Jensen Lake. There is some erosion evident as sediment is accumulating at the inlet of the RCP Culvert and the outlet of the pipe is slightly perched which should be stabilized with additional riprap to prevent undermining of the pipe structure (Figure 5-3). The erosion is most likely occurring from offsite drainage and therefore measures to intercept and infiltrate the stormwater should be taken. Steps should also be taken to stabilize the channel by thinning the tree canopy to open up for daylight to reach the ground and allow native grass vegetation to establish.

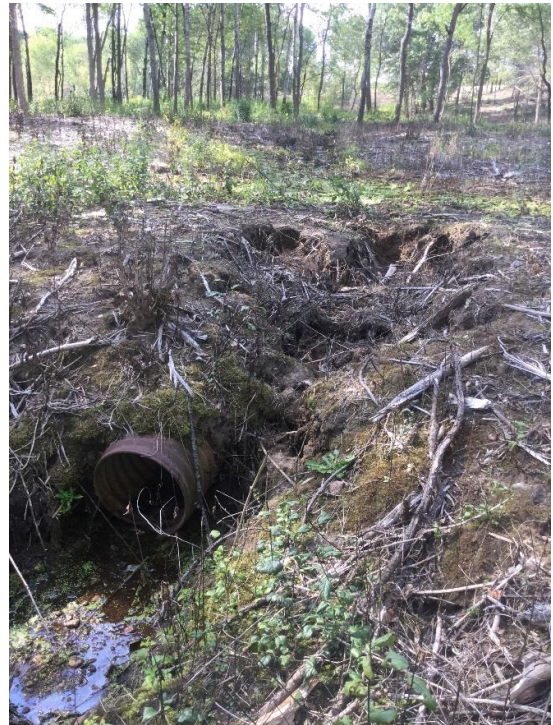
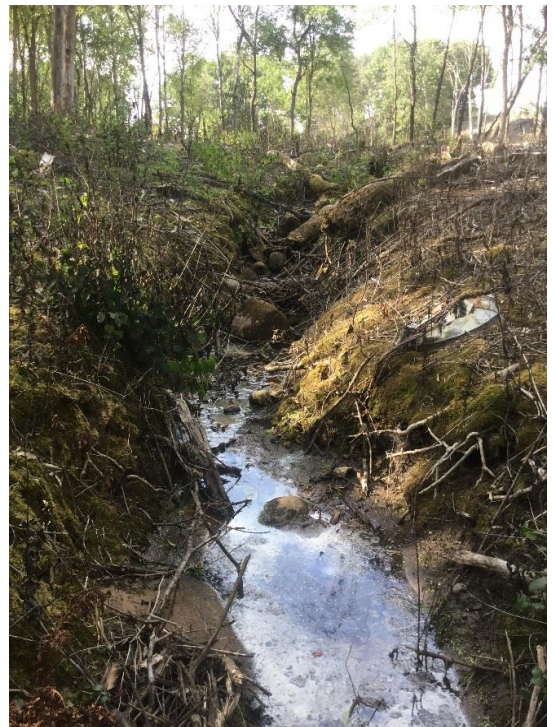
At erosion location 5H-6H, a wetland drains around a degraded Corrugate Metal Pipe (CMP) culvert that is no longer functioning properly. The CMP culvert is washed out overtop and runoff drains through an eroded gully/ditch approximately 75' in length, 5' wide, and 4' deep. The eroded ditch ends at another degraded CMP culvert underneath a walking trail. If the upstream culvert still has a function (trail crossing, controlled drainage, etc.) it should be replaced, otherwise this culvert can be removed. The downstream culvert has a rusted-out bottom and should be replaced before the trail is compromised. The replacement culvert should be either a high-density polyethylene (HDPE) plastic culvert or a reinforced concrete pipe (RCP) depending on the intended load crossing the culvert and the amount of cover that can be placed over the culvert. It is assumed in this report that an HDPE culvert will be sufficient.

The eroded channel has formed from an increase in runoff. It is likely that previously there was a natural channel with a slope that was tied into the downstream and upstream culverts. As runoff increased, a head cut formed at the downstream culvert. The head cut then migrated upstream until the point where it has now undermined and cut around the upstream culvert. Without stabilization, the head cut will continue to migrate upstream and export eroded soil to the downstream watershed. The existing conditions of the eroding ravine and the compromised culvert are shown in the photos to the right.

The proposed stabilization techniques include removing and replacing the downstream CMP culvert, stabilizing the toe of the channel with vegetated riprap, installing rock check dams in the channel to prevent future head cutting, removing the upstream CMP culvert, regrade the washed-out area of the channel, and placing a riprap spillway to prevent the head cut from reforming or migrating further upstream. Project construction would include grading work and selective tree removal upslope of the affected area to allow construction access and promote sunlight for the revegetated and reseeded areas. The priority for tree clearing will be in the order of:

The estimated construction cost for this project would be \$35,160. Appendix F provides a detailed cost estimate for each of the recommended items discussed above. By stabilizing this site, it is estimated that TSS loads to Holland Lake would be reduced by approximately 4.5 tons per year and TP loads would be reduced by approximately 1 pound per year.

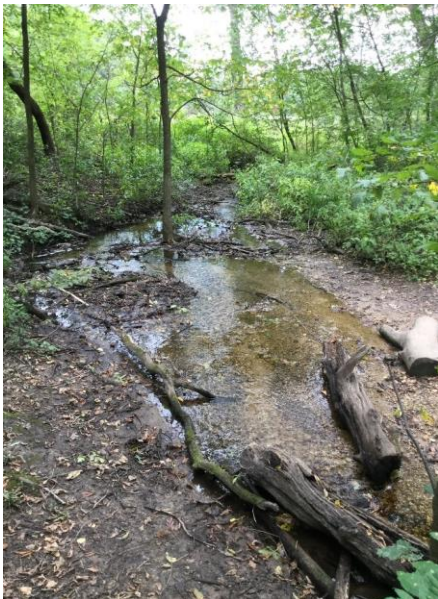
Schulze Lake Channel - Existing Stable Channel

Location 1S is a 18' wide channel, approximately 725' in length long that is mostly stable with organic sand/silt substrate as well and cobbles in the stream bottom. There is also woody debris scattered throughout the channel providing habitat opportunities for aquatic and terrestrial organisms. With increased runoff, the channel is migrating slightly and is creating undercutting along the banks of some outside channel bends. While channel migration is a natural process, it does export soil downstream and the increased runoff is accelerating this process beyond typical natural conditions. Protection of the banks will reduce the amount of soil being exported to downstream lakes, primarily Schulze Lake, within LHRP. Existing conditions of the channel in stable state compared to the eroding and undercut banks are shown in the graphics below.

Stabilization for this stream should be a more natural, bioengineered approach using native plantings and a combination of coir toe or cedar revetments, depending on streambank height and severity of erosion occurring, to rebuild the eroding outer bend sections that are eroding. Invasive species removal should be completed to remove the understory shading out existing grassy ground vegetation. Then the tree canopy can be assessed to see if selective removal of small pioneering, diseased or damaged, or low priority tree species will help to provide some additional sunlight and help revegetation efforts where bank restoration work is occurring. The coir log can be installed with shrub live stakes and/or bare-root plantings to build out and armor the toe of the bank. Cedar revetment would not be planted into, however the area above any cedar revetment or coir log toe work would be seeded with native, shade-tolerant grass and forb seed mix. No erosion control blanket would be needed since the seed would be broadcast and raked into the existing leaf litter. This project is estimated to reduce sediment loads to Schulze Lake by approximately 7 tons per year and phosphorus loads by approximately 1.5 pounds per year. The estimated construction cost for this project is \$21,060. Appendix F contains a detailed cost estimate for this project.

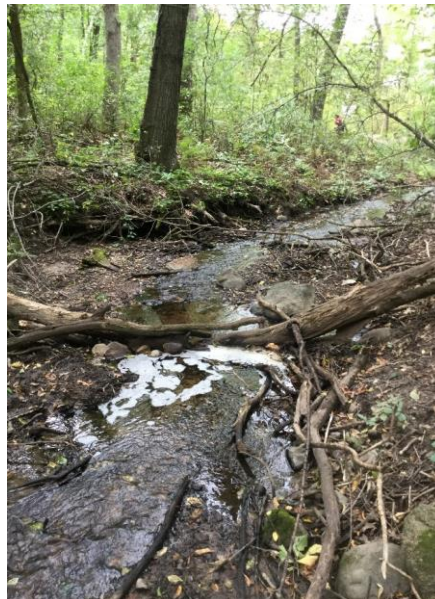
Schulze Lake Channel - Example of an Outer Bank Being Undercut

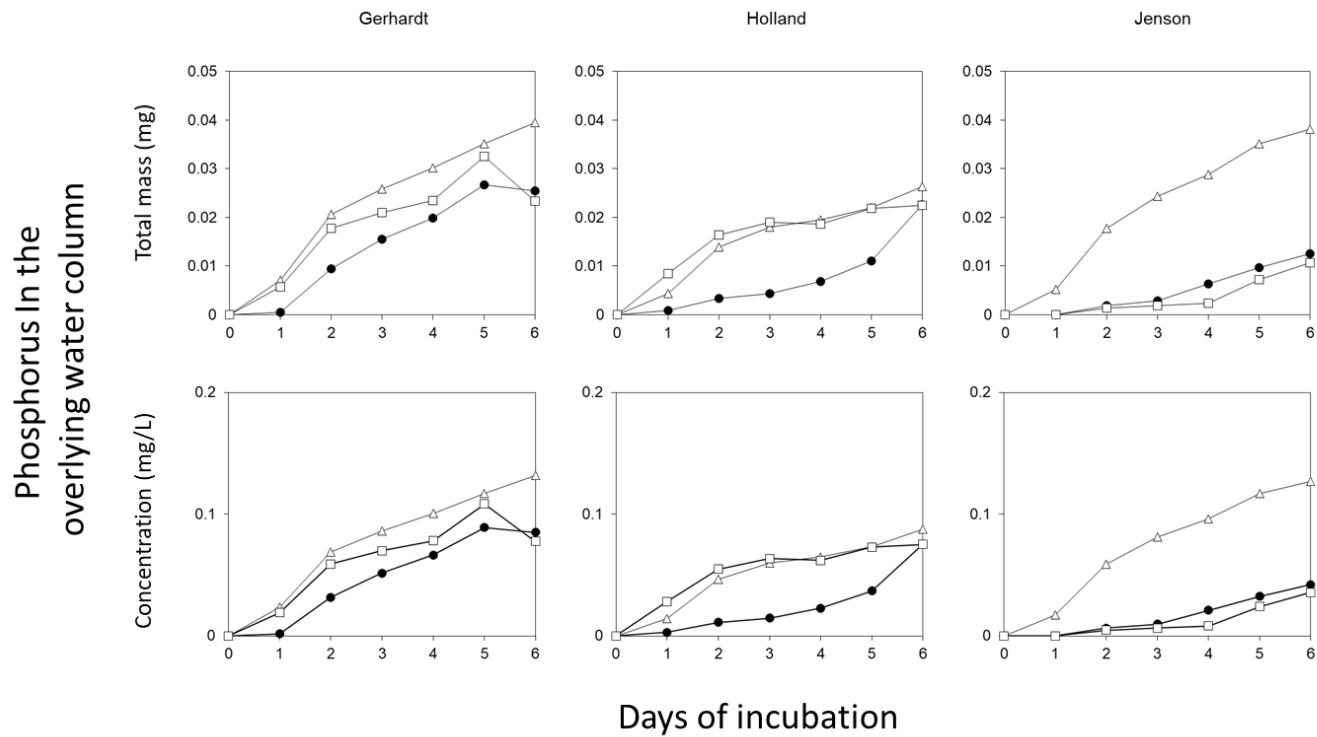
Figure 1. Changes in soluble reactive phosphorus mass and concentration in the overlying water column under anaerobic conditions versus time for sediment cores collected Gerhardt, Holland, and Jensen Lakes.

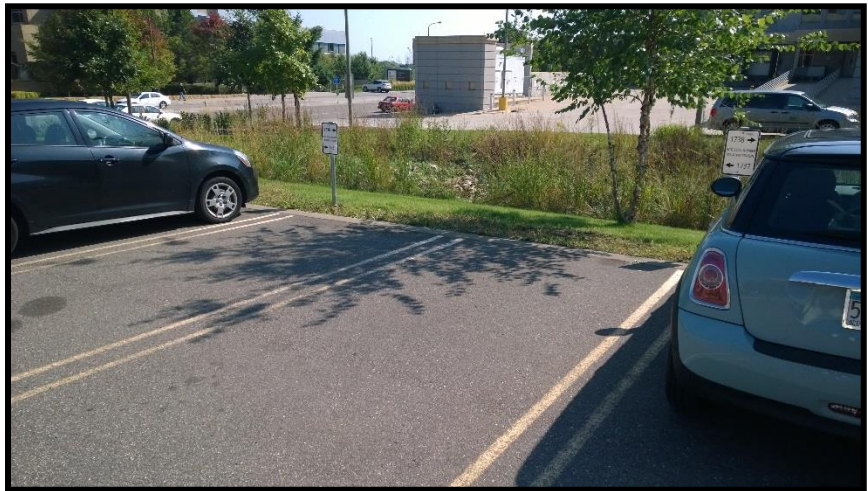
Infiltration basin along a parking lot in St. Paul, MN.

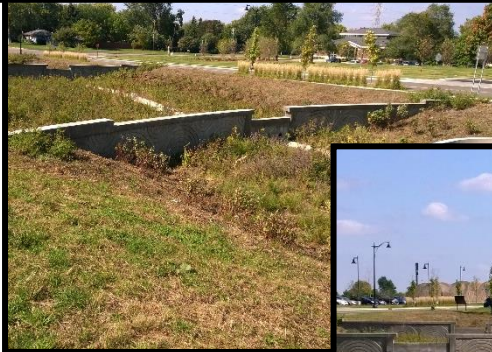
"Stepped" infiltration basin in Oakdale, MN.

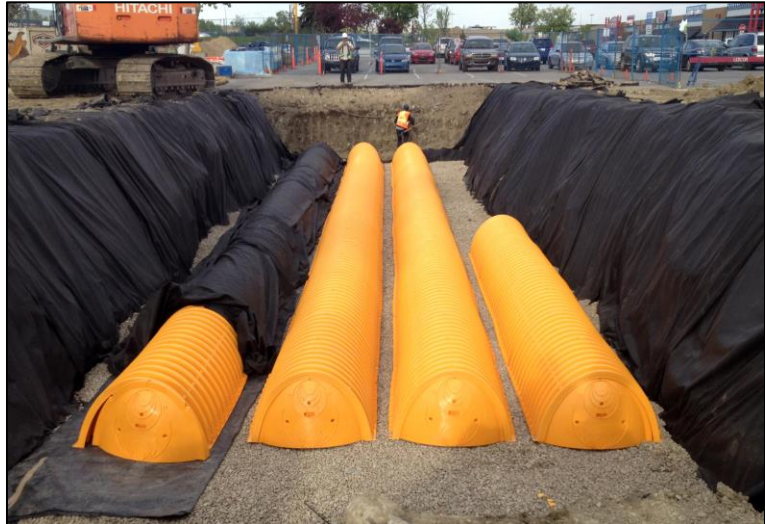
Infiltration trenches/ditches are stormwater practices that can be implemented within existing roadside ditch systems that are currently collecting and conveying stormwater runoff. Infiltration trench design includes an engineered soil at the ditch bottom to infiltrate surface water from low flow events. To maximize treatment storage volume, the design also includes underground storage which is typically a combination of chambers and/or aggregate void space. High flows bypass the infiltration trench by either flow continuing through the ditch past the infiltration areas, or bypassing through a flow splitter structure to a receiving water body. This type of infiltration trench/ditch design was recently incorporated within a county road ditch system in Dakota County that drains a highly impervious industrial park. These systems have performed very well in infiltrating a significant portion of the stormwater runoff and removing TSS and TP.

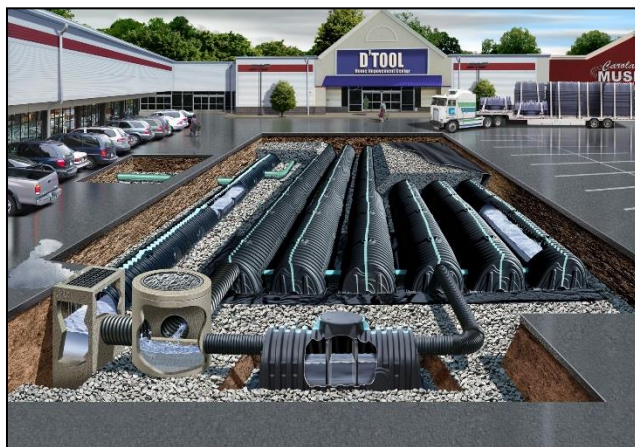
Underground infiltration systems are an adaptable stormwater BMP technique where space is limited, and is most suitable for highly urban areas where space is limited. Underground infiltration consists of perforated pipes, vaults, modular structures, or cisterns placed beneath a developed or open area. An example is shown to the right. Stormwater runoff is directed to this area via storm sewer for storage and infiltration. A manhole, filter, or hydrodynamic device provides pretreatment for runoff entering the storage area. In large storm events, the storage volume above the outlet reduces flow rates and discharge is directed into the storm sewer. Large angular rock (1-3 inches) surrounds the perforated pipes and provides additional storage capacity and structural stability for soils above. The design can be modified to include a filtration layer when infiltration is not practical.

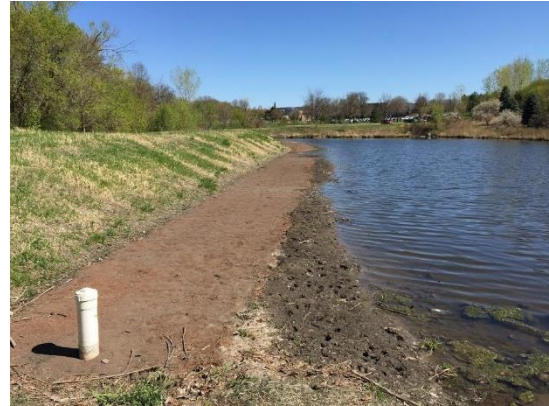
Iron-enhanced sand filters require underdrains that serve to convey filtered and treated stormwater and to aerate the filter bed between storms. The exit drain from the iron-enhanced sand filter should be exposed to the atmosphere and above downstream high water levels in order to keep the filter bed aerated. Iron-enhanced sand filters may be used in a treatment sequence, as a stand-alone BMP, or as a retrofit. If an iron-enhanced sand filter basin is used as a stand-alone BMP, an overflow diversion is recommended to control the volume of water, or more specifically, the inundation period in the BMP. As with all filters, it is important to have inflow be relatively free of solids or to have a pre-treatment practice in sequence.

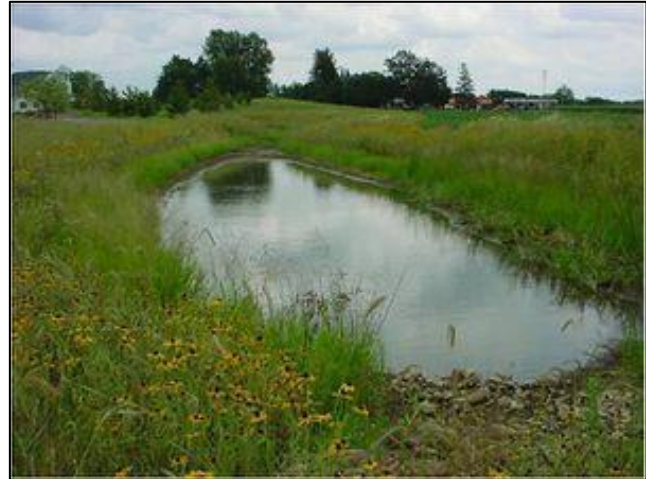
processes to remove pollutants from incoming stormwater runoff. The primary treatment mechanism is gravitational settling of particulates and their associated pollutants as stormwater runoff resides in the pond. In general, the longer the runoff remains in the pond, the more settling (and associated pollutant removal) and other treatment can occur, and after the particulates reach the bottom of the pond, the permanent pool protects them from resuspension when additional runoff enters the basin. Another mechanism for the removal of pollutants (particularly nutrients) is uptake by algae and aquatic vegetation.

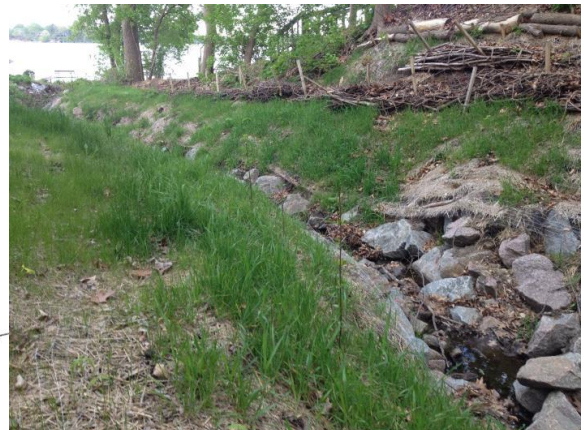
Detail of Vegetated Riprap and photo of installed practice on channel project one year after construction.

Vegetated riprap is a slope stabilization technique to be used in instances where flow velocity (5 – 20 FPS) requires hard armoring (rock) instead of bioengineered techniques. For this technique, the vegetation included in the design adds a more natural aesthetic by camouflaging the rock. Vegetated riprap is intended to provide toe protection on taller (> 4'), vertical, eroding stream banks. Riprap would be installed at the existing toe line of the side slopes and be keyed in slightly below the stream bed. Some bank disturbance would be required to make the vertical bank less steep (ideally, 2:1 H:V or less) by grading from the top of the bank to the new riprap toe. Final stabilization of the riprap toe areas would include revegetation with native seed and either erosion control blanket along the channel where high flows are expected and straw mulch or hydro-mulch in the upland areas. Installation of the riprap toe would follow the existing bank, would balance cut and fill on site and would not alter the channel cross section.

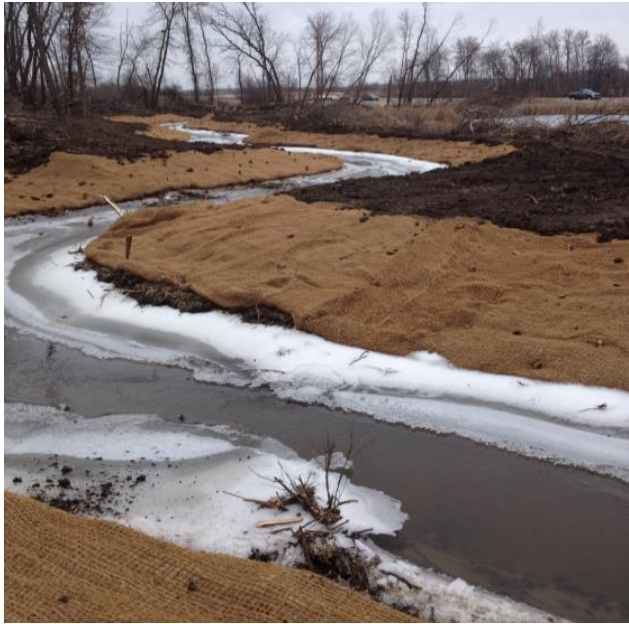
Bank resloping is a bioengineering stabilization technique to be used in instances where flow conditions allow (i.e. when channel velocities are less than 6 FPS) and/or for the portions of the bank above the normal high water level of a channel. Bank resloping is intended to establish native vegetation and provide toe protection on shorter (<3'), steep stream banks. Resloping the bank ranges from 3:1(H:V) or less (preferred), to no steeper than 2:1.

Bank sloping detail and photo of resloped banks constructed during winter on Elm Creek.

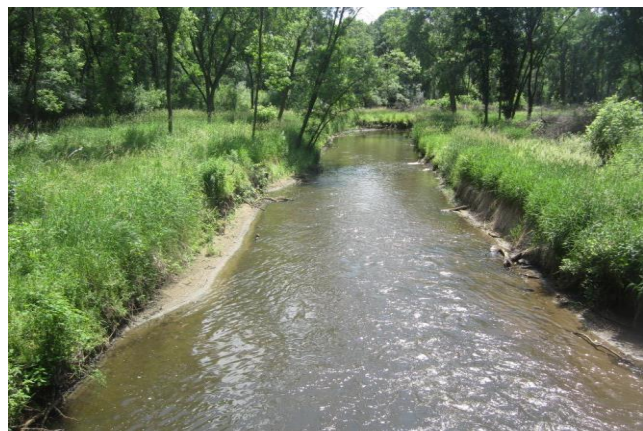
One year after clearing trees, the existing seed bank grew into a healthy grass buffer on Coon Creek.

Thinning existing trees to presettlement vegetation densities of 5 – 10 trees per acre, allows for more sunlight to reach the soil. Increased sunlight encourages the amount and vigor of ground plane grasses and forbs within the understory. This practice helps to stabilize floodplains adjacent to stream channel, thus mitigating soil movement into the adjacent and downstream waterbodies.

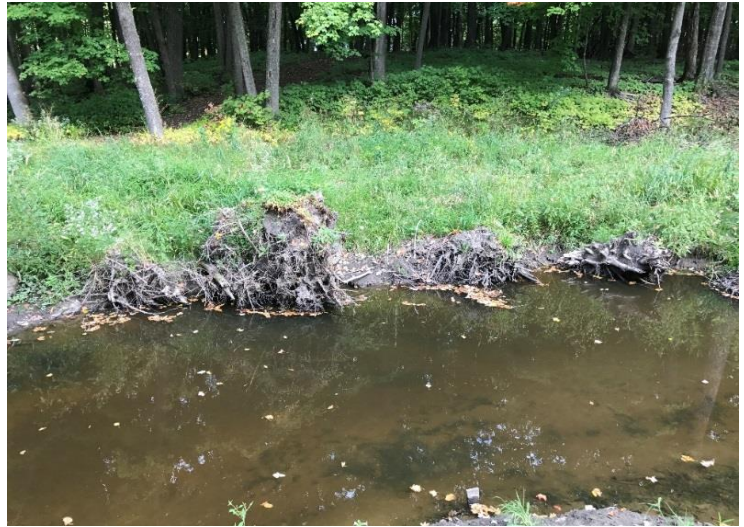
Installed rootwads two years after vegetation establishment and maintenance. The rootwads have grown into the stream bank. Log toe was installed, but is not visible (submerged under the water line) in this photo.

Rootwads with log toe is intended to provide toe protection on taller (> 4'), vertical, eroding stream banks and would be installed at the existing toe line of the side slopes and be keyed in slightly below the stream bed. Some bank disturbance would be required to install the rootwads and log toe, with the top of bank restored to be less steep (ideally, 2:1 H:V or less) by grading from the top of the bank to the new rootwads with log toe. Final stabilization of the rootwad and log toe areas would include revegetation with native seed and erosion control blanket along the channel where high flows are expected or straw mulch or hydro-mulch for stabilization in the upland areas. The rootwads and log toe would follow the existing bank, would balance cut and fill on site and would not alter the channel cross section.
