Vermillion River Greenway-Hastings Segment

Natural Resource Management Plan

2023

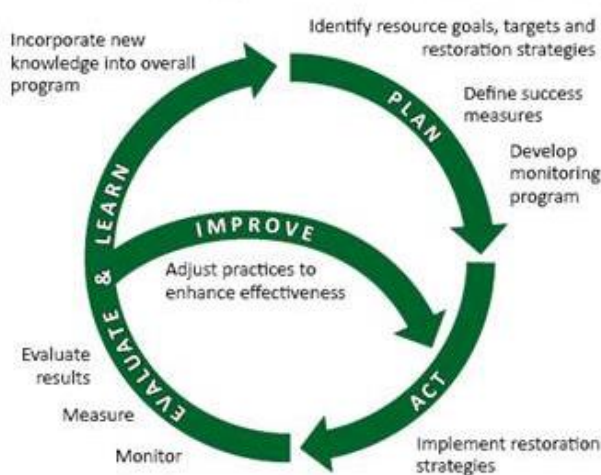
Figure 3. Adaptive Management Approach Schematic

The overarching goal is to return and maintain a diverse native plant community within a site, though this will not always follow a linear progression. Using the concept of adaptive management will be the key to continual progress. Adaptive management integrates thought and action into the restoration process and can be described as a process that uses evaluation, reflection, and communication to incorporate learning and responsiveness into planning and management.

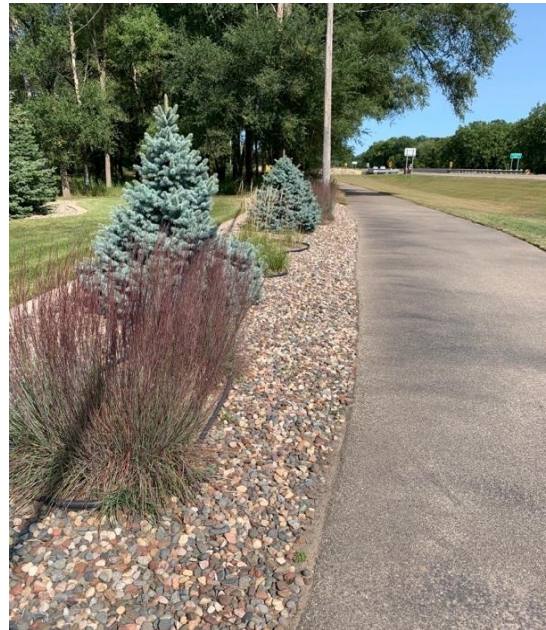
changed considerably over the last century. The river was moved south from its original alignment in a flood diversion project in the 1940s, and approximately 1000 feet of streambank at the outside bend of the river is currently hard armored with riprap. The City of Hastings owns approximately 4 acres on the south side of the river, but this land is surrounded by private properties that prevent access. Four of these private properties line the paved trail that runs parallel to County Road 47, and their residential landscaping spills over beyond the private parcel boundaries including a dense stand of silver feather grass (*Miscanthus sinensis*) as shown in Photo 6.

Photo 6. Paved Corridor West of Highway Dept.

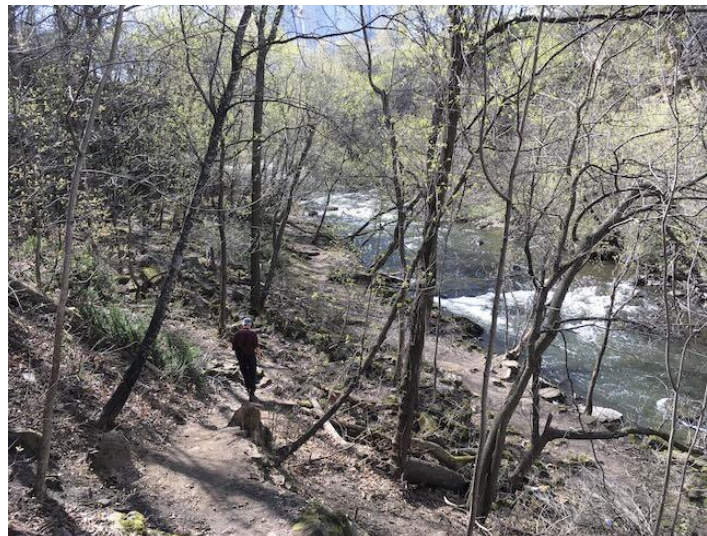
Photo 9. Maple-basswood forest after invasive woody removal. Note the formation of unofficial trails.

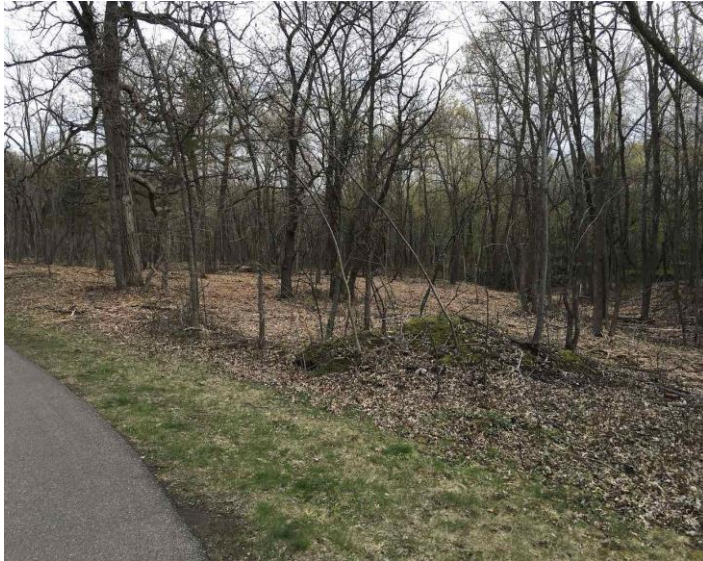
Photo 10. Degraded woodland after forestry mowing to restore native plant community.

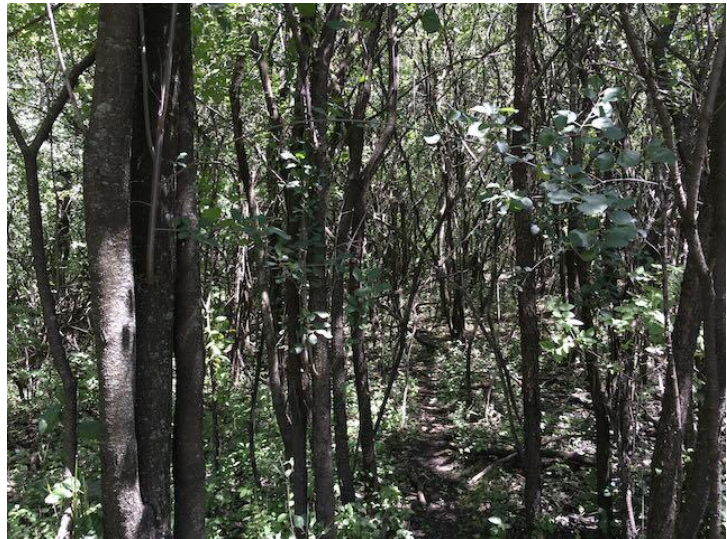
Photo 11. Very degraded woodland prior to restoration.

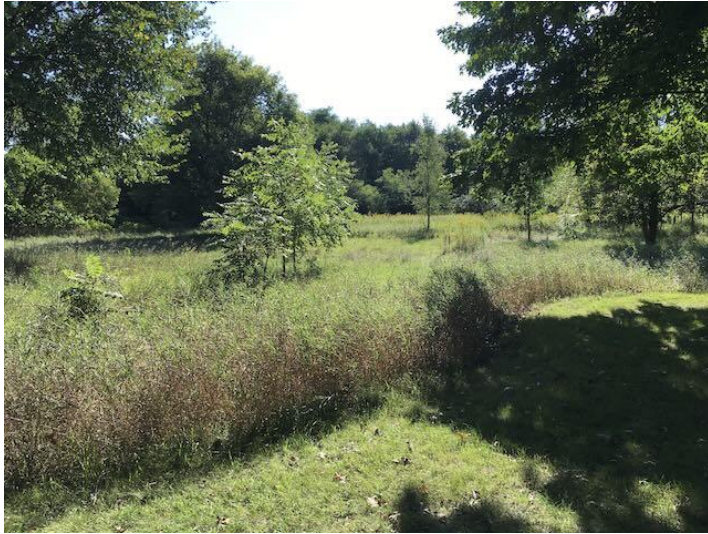
Photo 12. Non-native grassland before restoration to savanna.

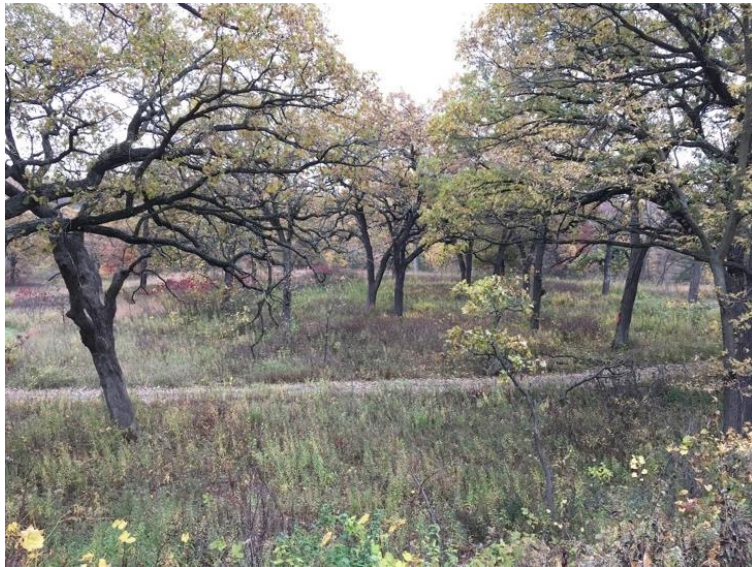
Photo 13. Remnant oak savanna that has been managed and maintained for over 10 years.

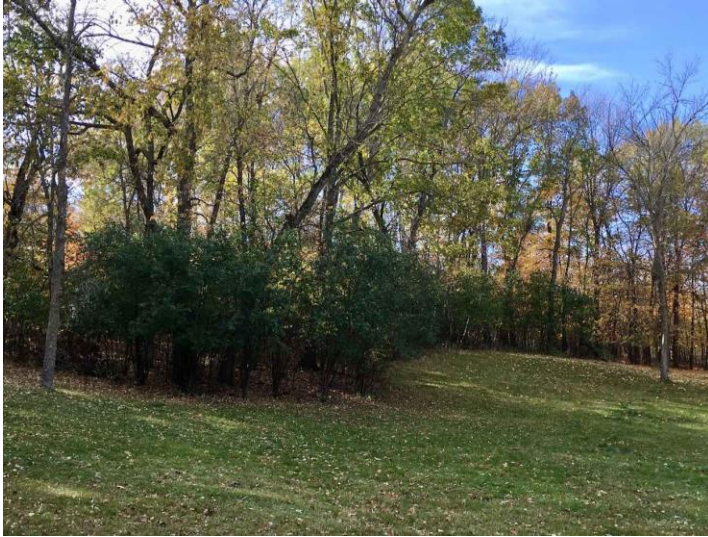
Photo 14. Invasive shrubs dominate most of the wooded areas.

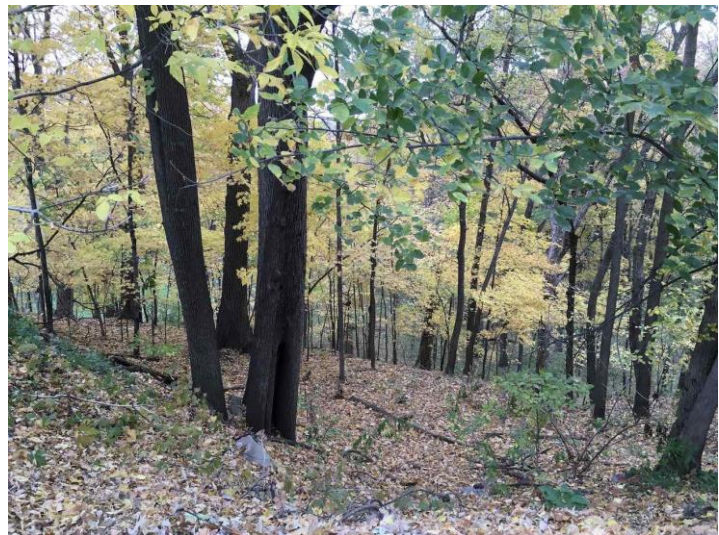
Photo 15. Maple-basswood forest with few invasive species except along edges.

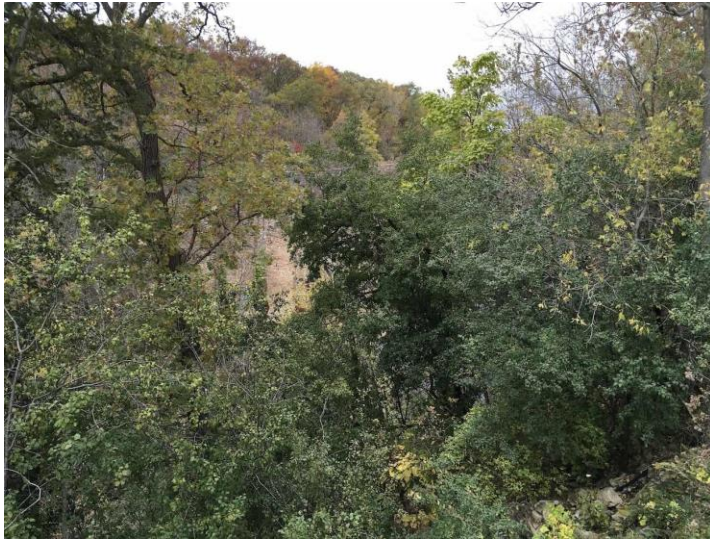
Photo 16. Buckthorn along the Vermillion River obscures views of the mill ruins.

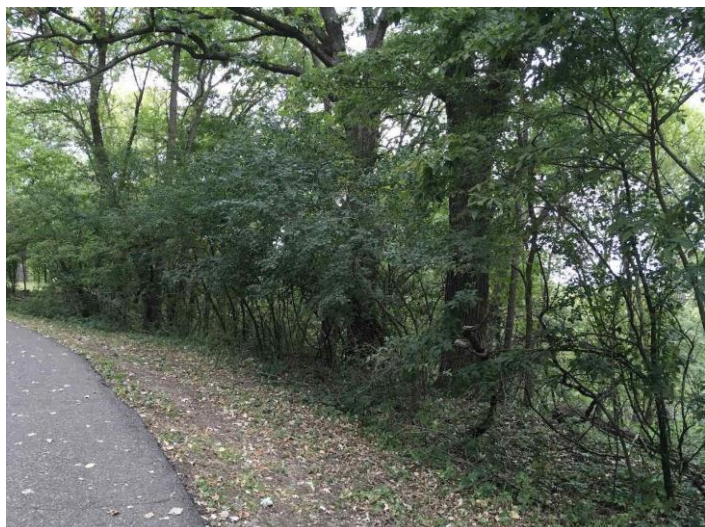
Photo 19. Buckthorn dominated the understory of altered woodlands.

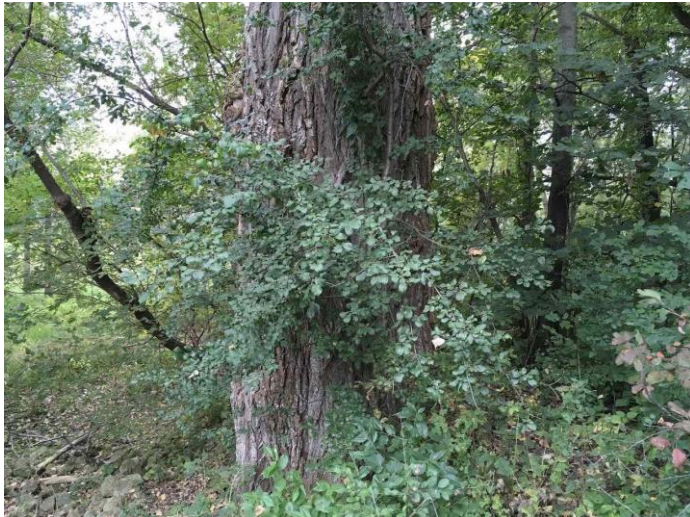
Photo 20. Several very large cottonwood trees were found in the floodplain forests. Invasive woody plants were most abundant along edges.

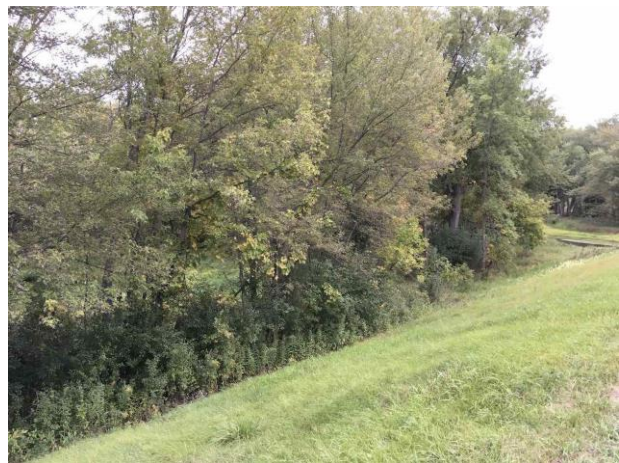
Photo 22. Invasive woody plants were most common in lowland forests and roadsides.

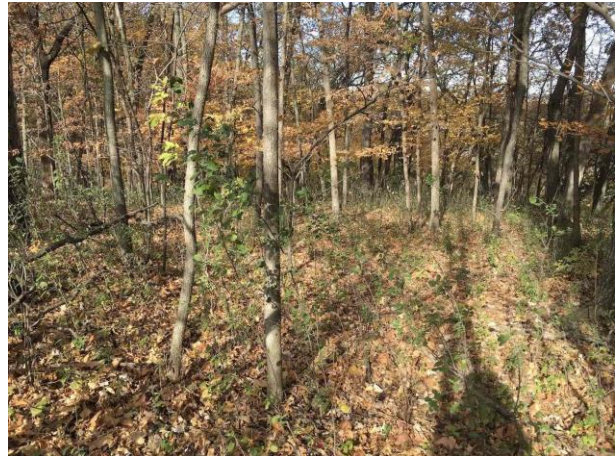
Photo 24. Buckthorn seedlings were regenerating in previous removal areas of the south woods.
