# Lake Byllesby Regional Park Natural Resource Management Plan

## Adopted by the Dakota County Board on January 23, 2018

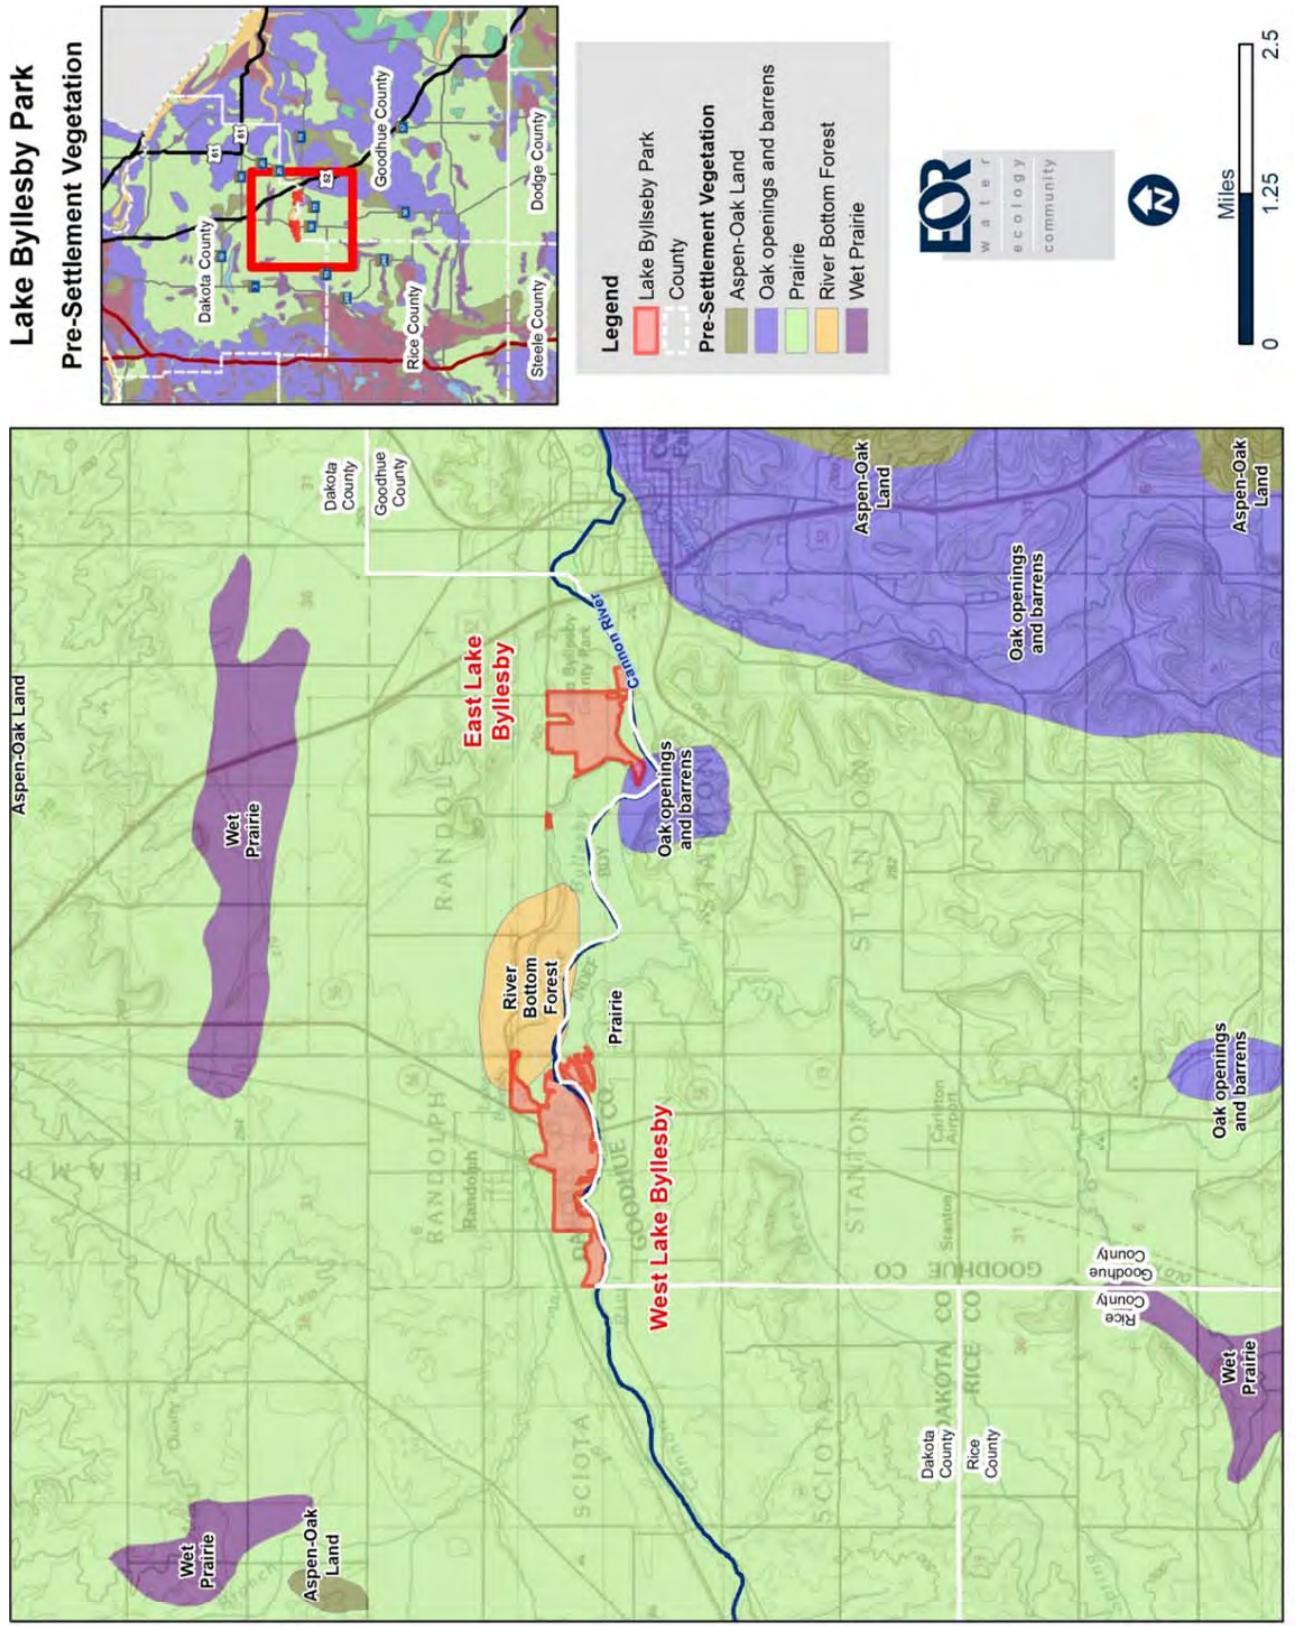
Figure 2. Predominant, pre-settlement plant communities of the Park

Based on historic vegetation mapping data, the Park is located in an area that was dominated by prairie (Figure 2). Oak openings and barrens may have been found in a small southern sliver of the East Park Unit. Historical mapping denotes river bottom forest may have occurred along portions of the river that formed the reservoir Wet prairie and aspen-oak land were also mapped in areas surrounding the Park.

The southern two-thirds of the County consisted primarily of prairie and savanna (Figure 2). Savannas with scattered oak trees formed transitional plant communities between grasslands and forests. Depending on soils, topography and hydrology, tallgrass prairie (with dominant grass species measuring as high as eight feet, with a diverse mix of other grasses and wildflowers [forbs]) would have been the prominent vegetation type. Shorter grasses and a wide variety of other forbs would have been found on sandy and gravelly areas on steep slopes. Depending on the frequency of fire, those areas that burned less often would have consisted of brush-prairie, including a diversity of prairie species mixed with scrubby shrubs and short trees.

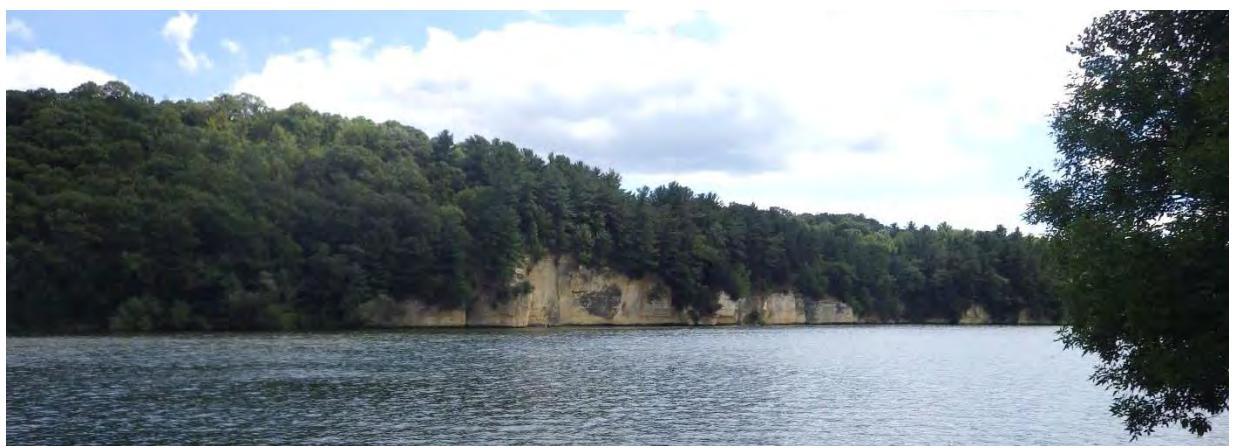
Exposed rock ledges on south shore of Byllesby Reservoir, Goodhue County.

The uppermost bedrock found within the Park boundary is the Prairie du Chien Formation. The Prairie du Chien formation is a dolostone with thin beds of sandstone and chert. The sandstone hill located east of Lake Byllesby and prominent cliffs of the south side of the reservoir are comprised of St. Peter Sandstone and the Platteville-Glenwood shale (MGS, 2000; Figure 9).

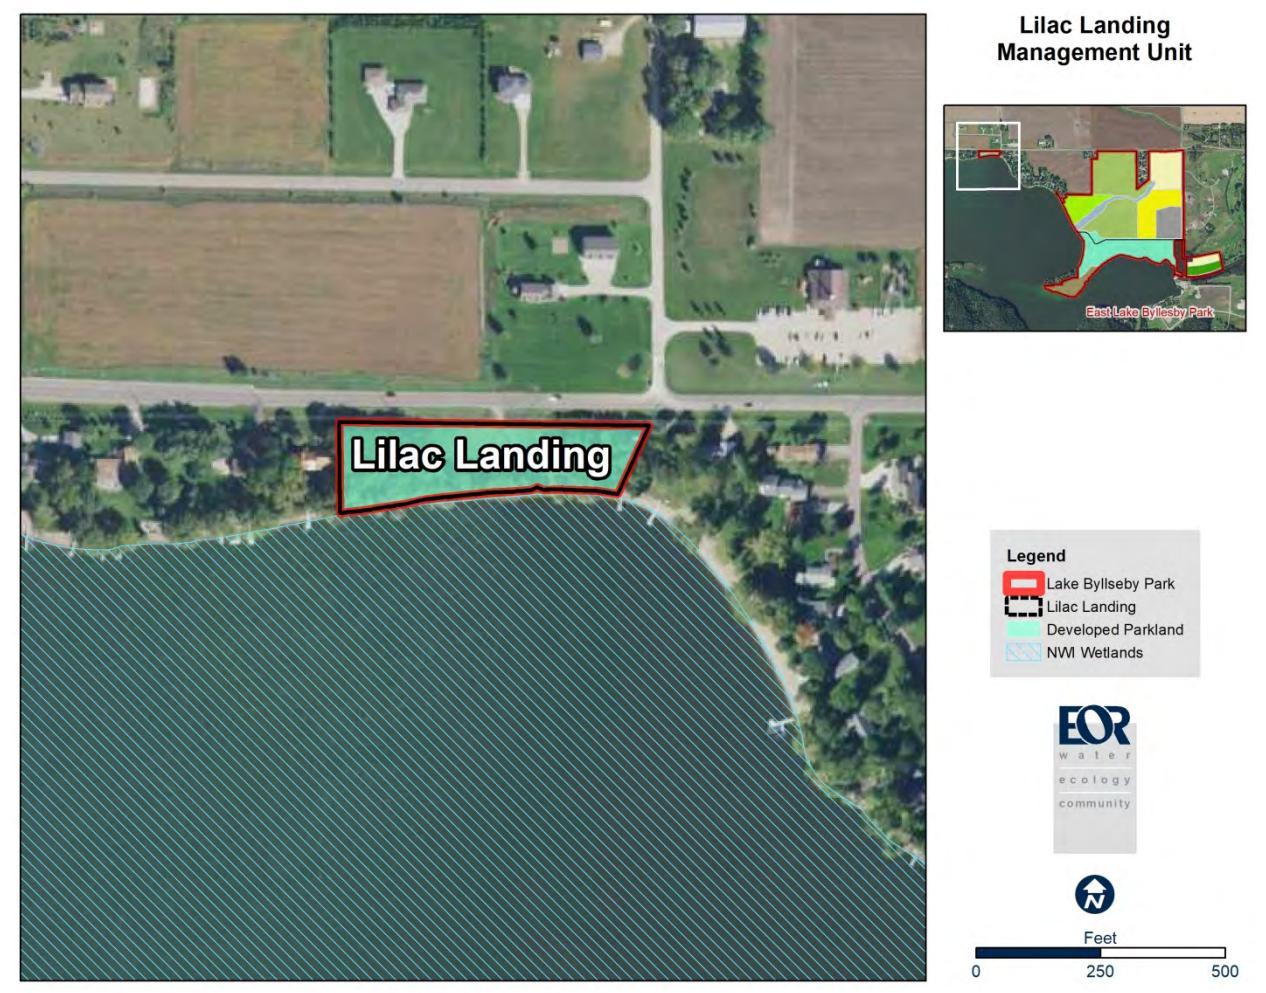
Figure 27. Lilac Landing Management Unit (2.0 acres)

The Lilac Landing Management Unit is a small section of the Park northwest of the contiguous East – Lake Byllesby Unit. Lake Byllesby forms the southern edge of this Unit. No water resources are found within this Unit.

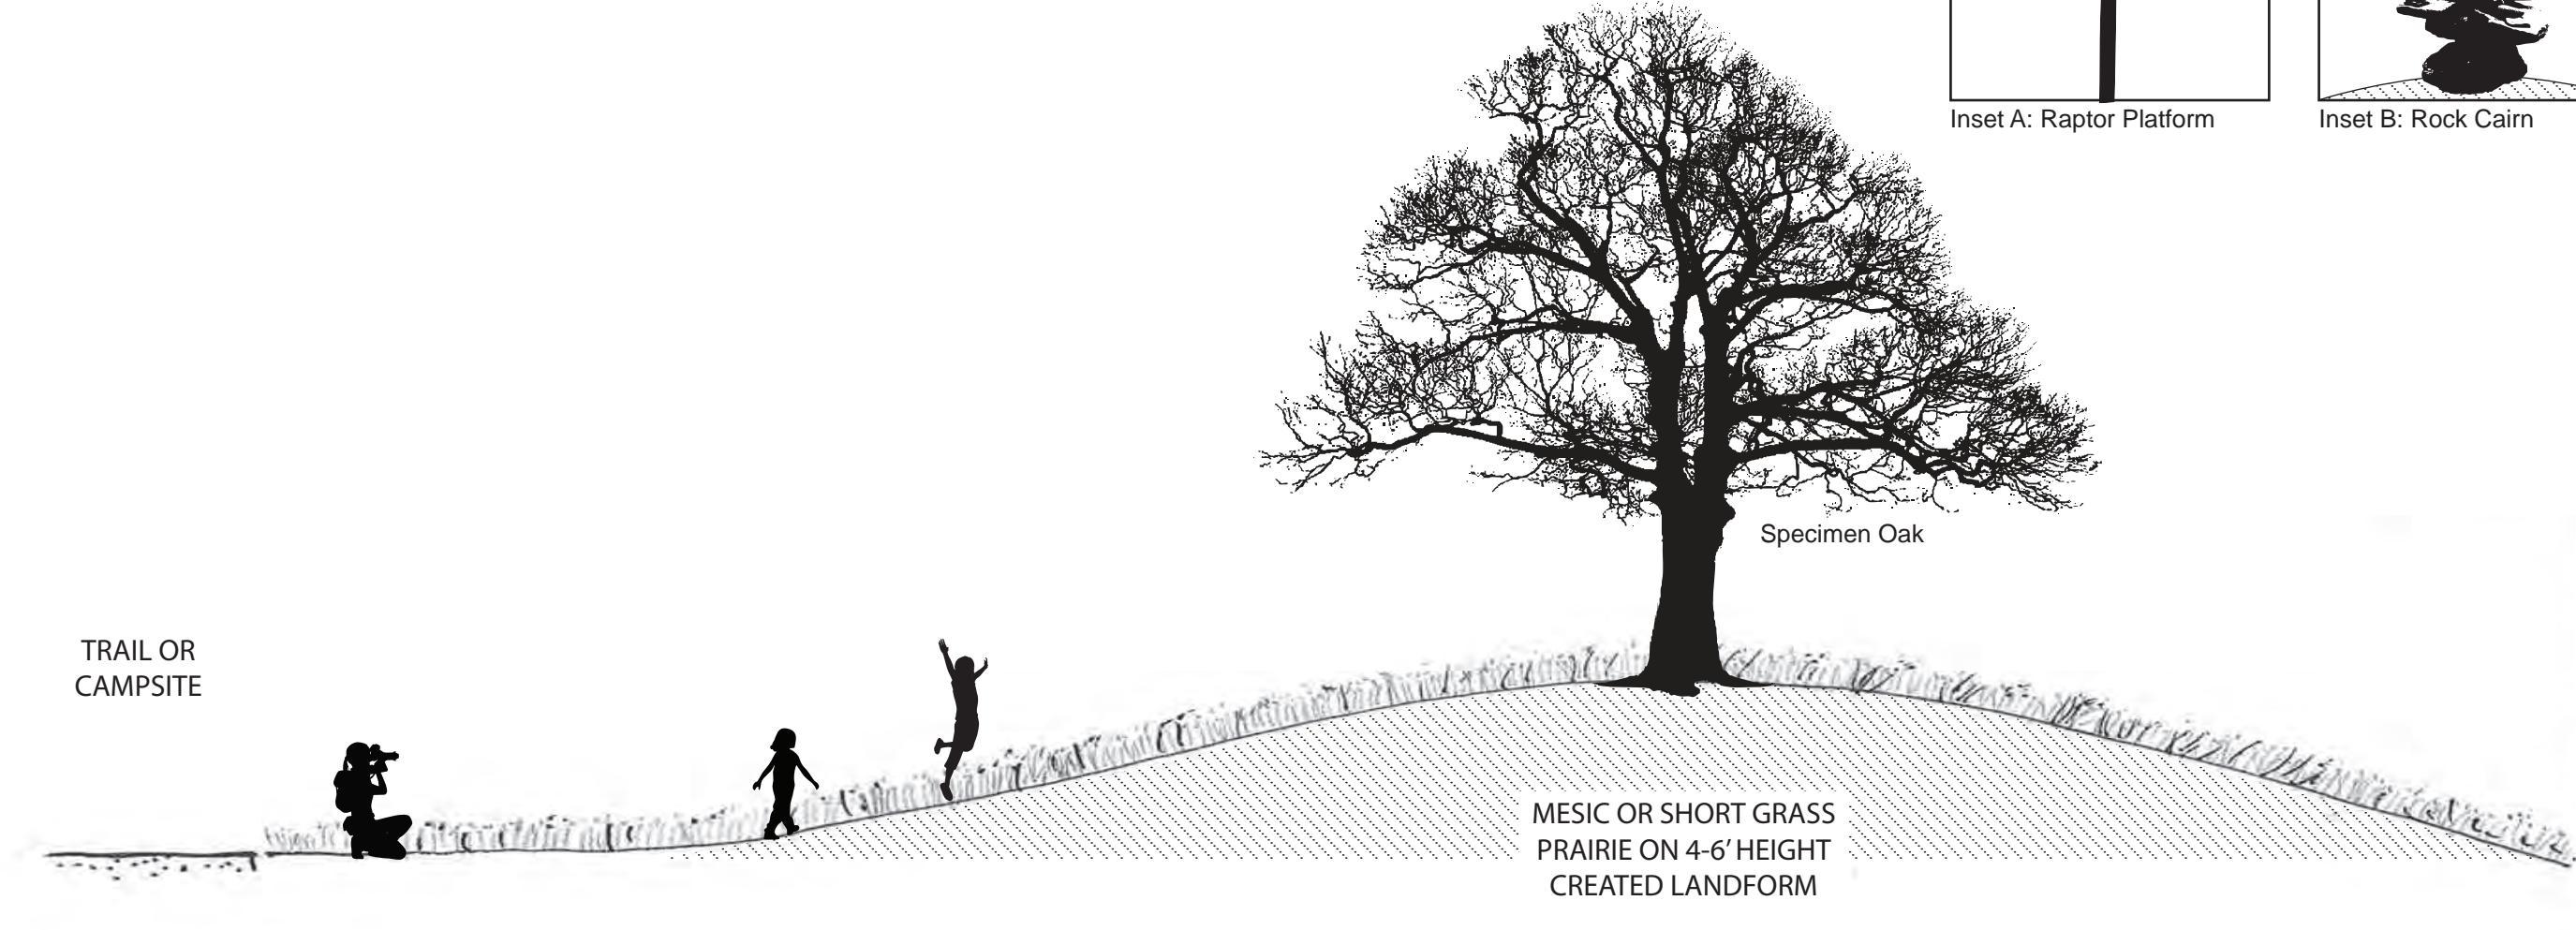
The focal draw landscape attraction uses landform as well as vegetation (or other landscape features) to create focal points in the landscape that attract interest and draw visitors out of maintained camp areas and into the naturalized space of a prairie restoration. One way this can be done is to transplant a large, unique specimen tree on top of a short berm a few dozen yards away from a trail or campsite. The tree will provide visual interest from afar and will draw visitors to it, across the prairie, for further exploration. Other elements that could be used as a focal draw include a raptor platform, rock cairn, art installation, large boulder, or even a downed tree.

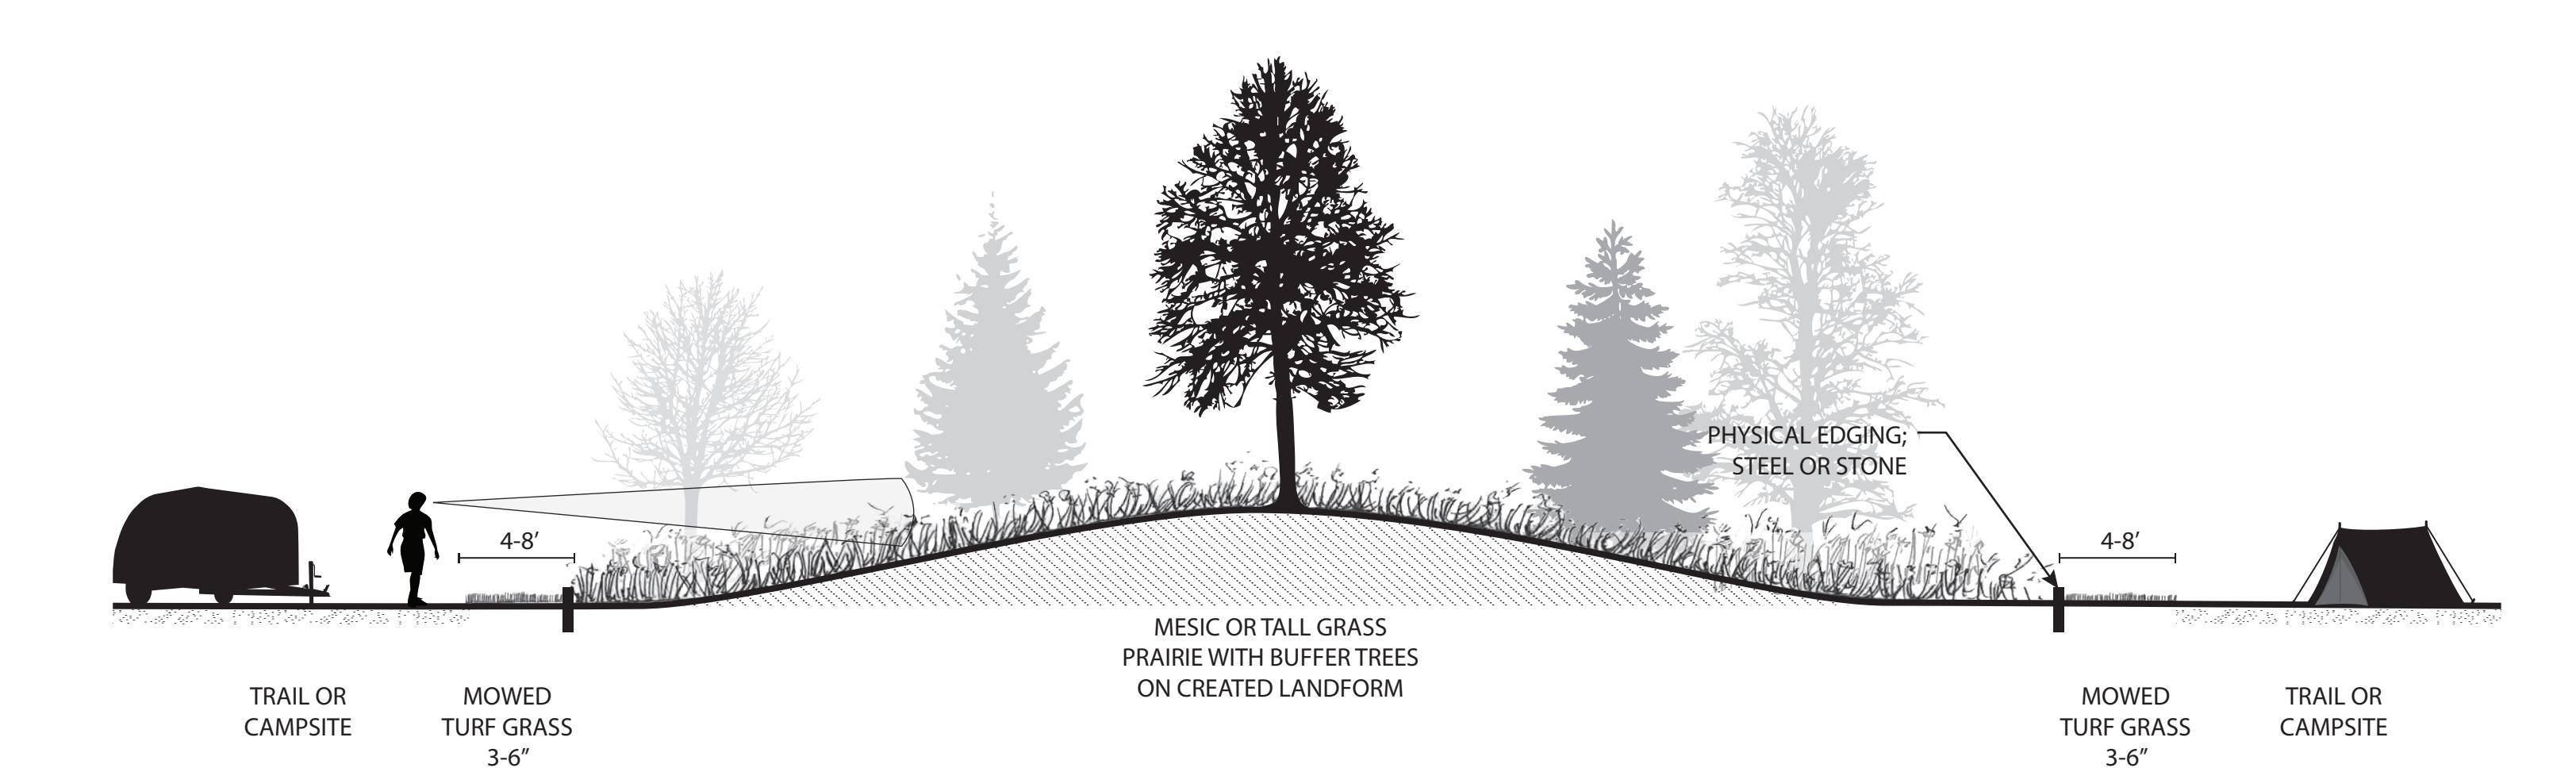
The formal buffer provides a spatial barrier between active park programs using naturalized prairie restoration areas interspersed with trees. This buffer area is bordered by mowed turf grass, which reduces the number of insects in human-occupied areas and reduces the incidence of prairie plants creeping into maintained park areas. It also provides a psychological separation of park programs for campers and hikers. A physical edging material delineates the break between mowed and naturalized areas which helps ensure maintenance of a consistent edge.

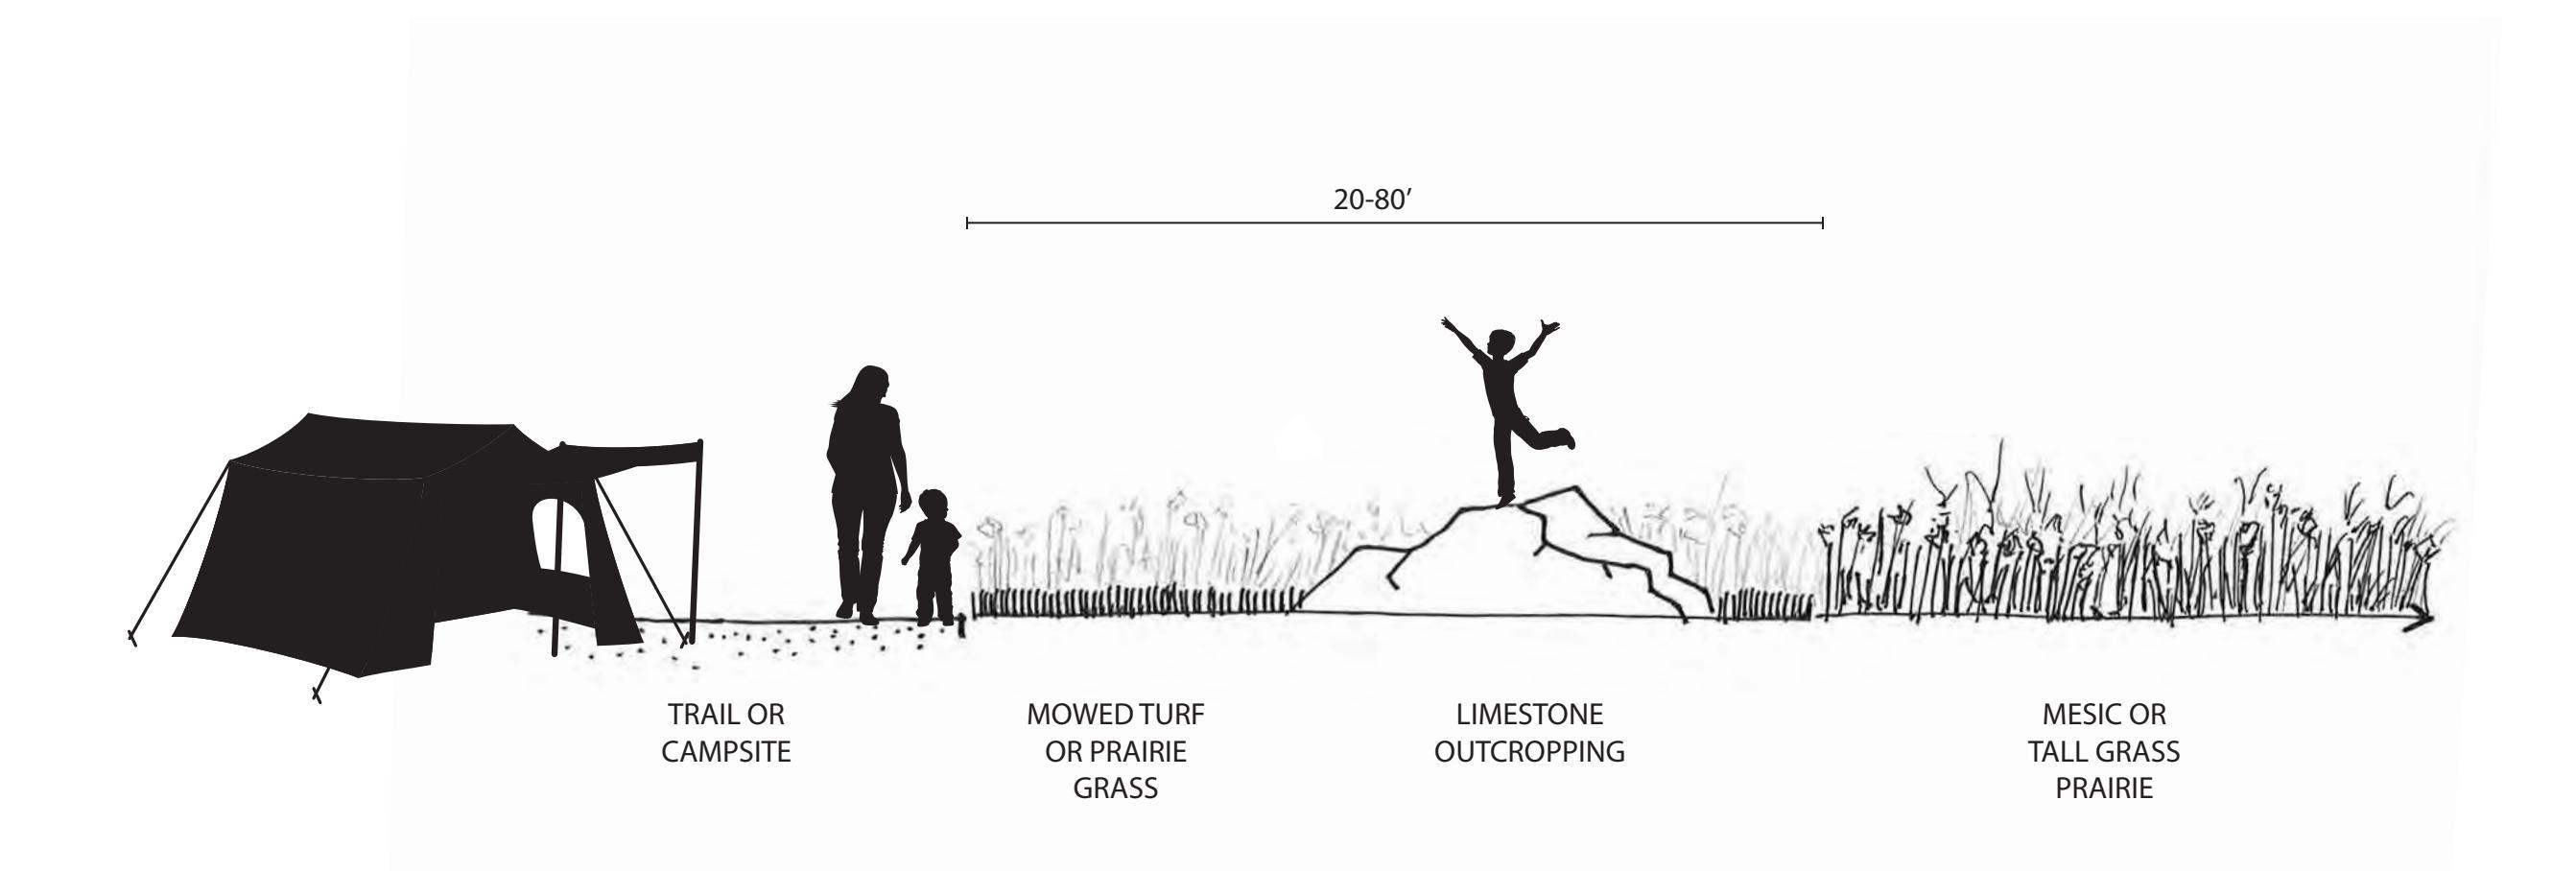
The permeable buffer provides specific opportunities for park visitors to penetrate the prairie setting, without stepping off mowed/maintained areas that are easily accessible. Special points of interest (such as rock outcroppings or downed tree trunks) should be placed within this landscape to draw visitors out of planned programmatic areas and into this interstitial park space.
