# DAKOTA COUNTY PLANNING COMMISSION

# Meeting Minutes: Dakota County Planning Commission Advisory Committee Meeting Minutes-DRAFT

# Vermillion River Greenway-Hastings Segment

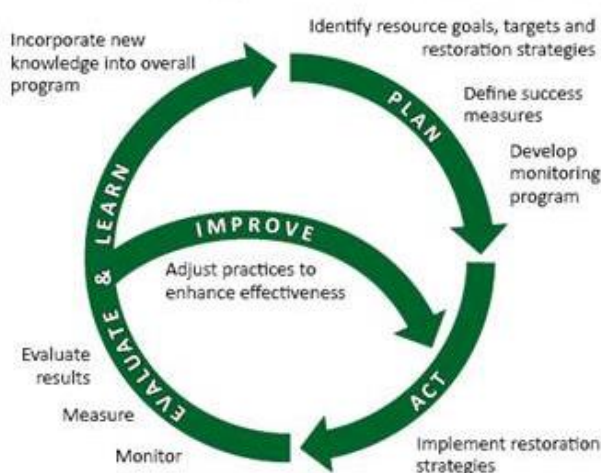
Figure 3. Adaptive Management Approach Schematic

The overarching goal is to return and maintain a diverse native plant community within a site, though this will not always follow a linear progression. Using the concept of adaptive management will be the key to continual progress. Adaptive management integrates thought and action into the restoration process and can be described as a process that uses evaluation, reflection, and communication to incorporate learning and responsiveness into planning and management.

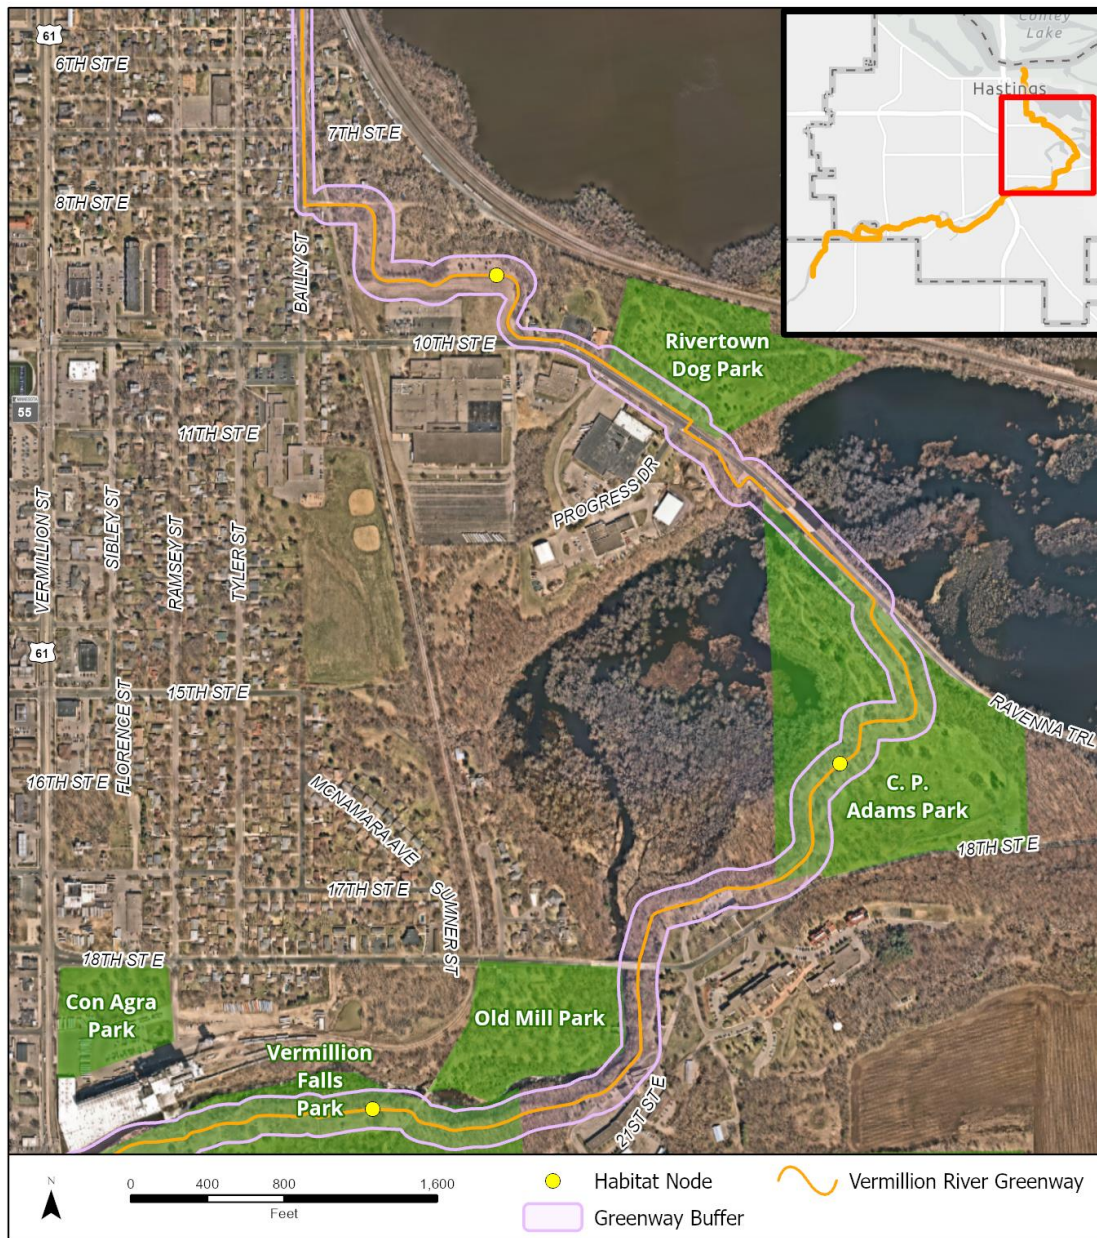
Figure E-1. Greenway corridor schematic. The northern part of the segment will consist of a 100-foot, urban greenway corridor, and the southern part, starting at the Rivertown Dog Park will consist of a 300-foot, rural greenway corridor, with the portion between them consisting of a mix of urban (100-foot), rural (300-foot) and suburban (200-foot)

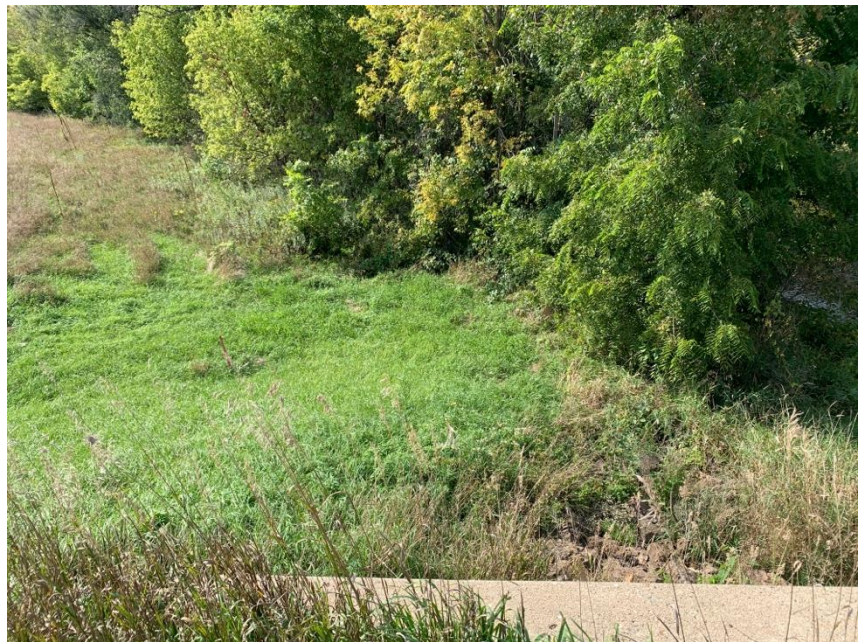
Photo 3. East of Jorgen Avenue

with silver maple, green ash, black walnut, white oak, and red oak all present. There is regeneration of these species in the subcanopy with light- to moderate common buckthorn in the shrub layer. Smooth brome dominates the grassy field edge of the cultivated field (soybeans) at the northwest corner of Pleasant Drive and 160<sup>th</sup> Street East (Photo 3). The MLCCS cover type map indicates a lobe of *Medium-tall grass altered/non-native dominated grassland* along the streambank; this may indicate a small remnant prairie. Recent aerial imagery shows an open area on this parcel that may be presently mowed. The other parcels have closed canopies, and given the abundance of buckthorn on nearby properties, it can be assumed that these woodlands also have buckthorn unless they have been managed to prevent invasion.

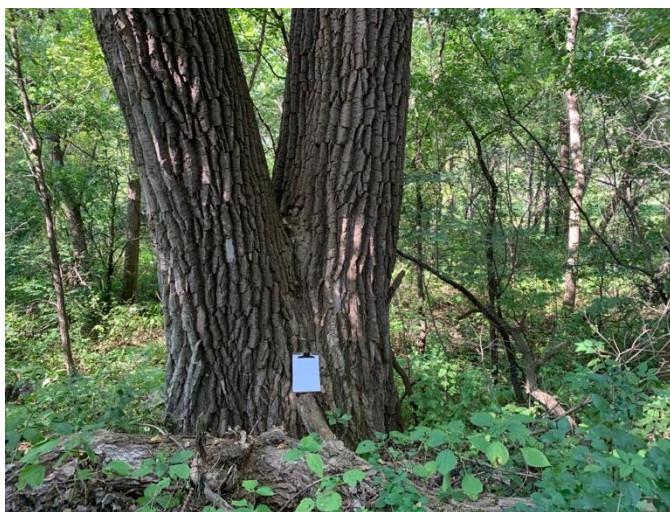
Photo 4. Large cottonwood east of Pleasant Drive

Four privately-owned parcels totaling approximately 67 acres comprise the section of greenway east of Pleasant Drive before the Vermillion River turns south and travels under County Road 47. The Vermillion River Trail traverses these parcels within an easement conveyed to the City of Hastings, but the trail typically closes from December 15 to March 15 as no maintenance occurs through the winter. The three western parcels are row cropped, and the fourth parcel is a homestead with a mix of short- and medium-grasses that are non-native according to the MCLLS cover map. The eastern edge of this parcel has both jack pine and short grasses and may have remnant plant communities. A wide *Lowland hardwood forest* is present within the floodplain of the Vermillion. The floodplain here is quite wide (150-200 feet) in some areas with very large eastern cottonwood (Photo 4) and silver maple present and hackberry and Siberian elm in the understory. Several culverts run under the trail allowing for flood flows to reach the wide floodplain, and for water stored in the floodplain to reach the river when lower flows occur. On higher ground at the edge of the cultivated fields, black walnut is very abundant. The shrub layer is dominated by buckthorn, but management is planned by the City of Hastings. Several social trails (unofficial footpaths) run from the paved trail to the river where people attempt to access the river despite private property postings. This is likely contributing to weediness in the herbaceous layer: garlic mustard is abundant in this unit.

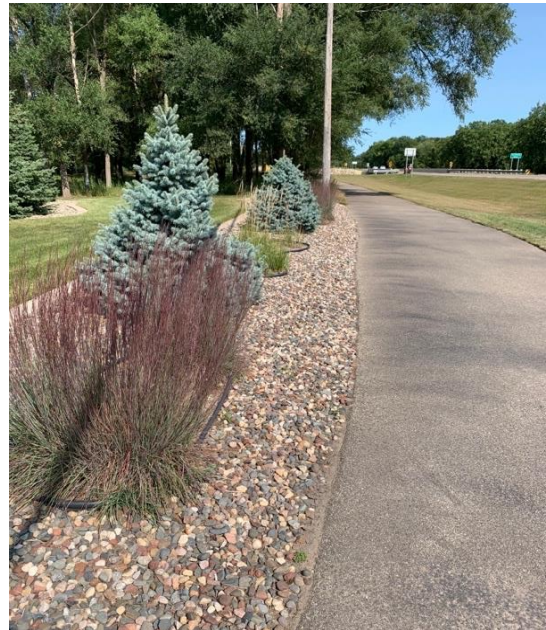
Photo 6. Paved Corridor West of Highway Dept.

changed considerably over the last century. The river was moved south from its original alignment in a flood diversion project in the 1940s, and approximately 1000 feet of streambank at the outside bend of the river is currently hard armored with riprap. The City of Hastings owns approximately 4 acres on the south side of the river, but this land is surrounded by private properties that prevent access. Four of these private properties line the paved trail that runs parallel to County Road 47, and their residential landscaping spills over beyond the private parcel boundaries including a dense stand of silver feather grass (*Miscanthus sinensis*) as shown in Photo 6.

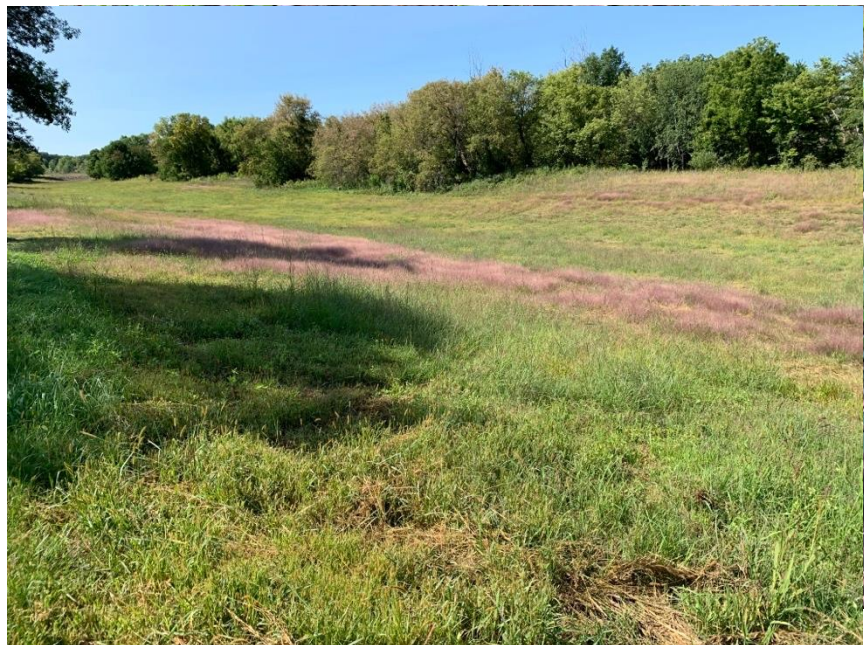
Photo 7. Spillway at Vermillion River Linear Park

stabilization of the streambanks, and native plant establishment in the spillway or bypass channel at the center of the park (Photo 7). Some invasive woody shrub management has also been completed on the periphery of the park.

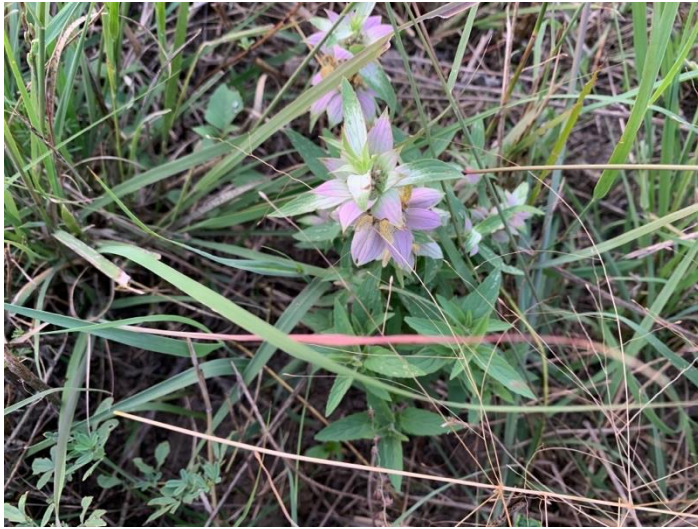
Photo 8. Dotted mint at Vermillion River Linear Park

Conversion to native plant communities is in process as of late 2022 and will continue for at least 5-10 years. Side oats grama, big bluestem, and gray-headed coneflower are plentiful in the upland prairie areas, which is typical of early establishment restored grasslands. Native wild lupine, dotted mint (Photo 8), and porcupine grass are also

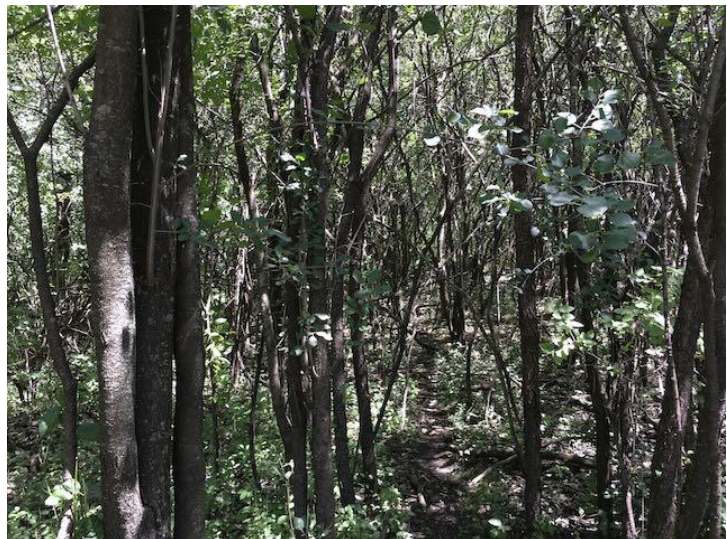
*Photo 11. Very degraded woodland prior to restoration.*

Ecological restoration is well underway at the park, with invasive woody removal completed on the north and eastern wooded areas (Photo 10) and seeding with native species completed. The degraded woodlands in the central part of the site (Photo 11) will be managed for invasive woody plants in winter 2023 and the conversion of the non-native grasslands (Photo 12) to oak savanna will also begin in 2023.

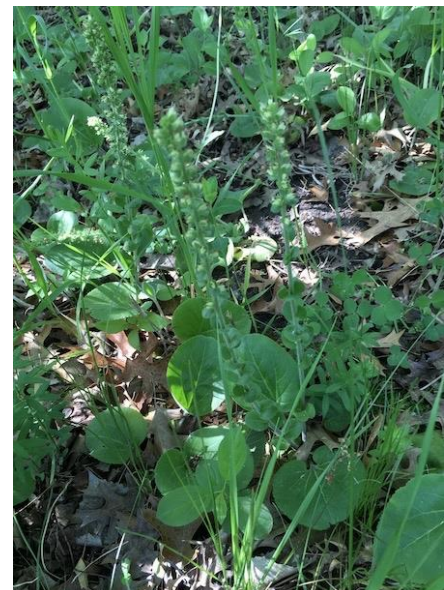
Photo 12b. Kittentails at Vermillion Falls Park, May 31, 2023.

One rare (state-threatened) plant species, kittentails (*Besseyia bullii*), is found at the park (Photo 12b). In 2019, several plants were found at the City of Hastings Vermillion Falls Park by Friends of the Mississippi River (FMR) as part of a natural resource management plan process. A targeted survey was not conducted at that time, but several patches were noted in the plan.

were readily detected at that time, as they were at a late flowering stage, and the vegetative growth of other plants was still relatively low and not obscuring the kittentails.

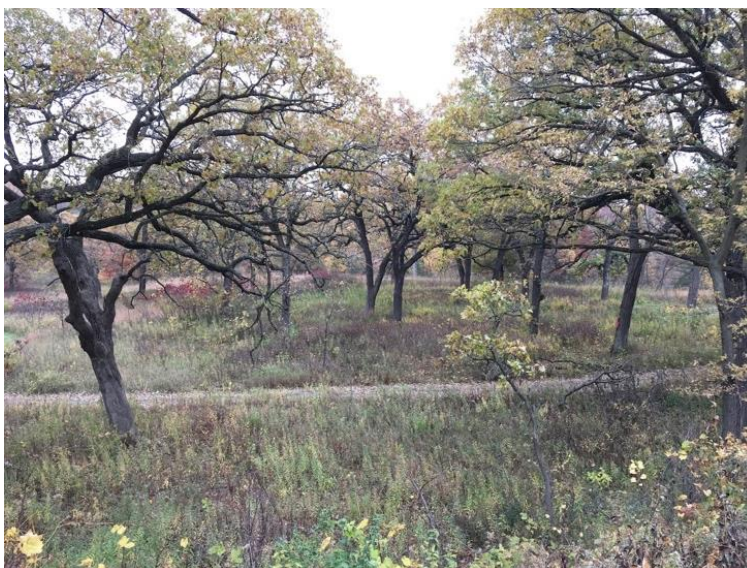
*Photo 13. Remnant oak savanna that has been managed and maintained for over 10 years.*

Present ecological conditions of the park are very good, with the oak savanna and oak woodland well-established and diverse native plant communities generally sustaining (Photo 13). The park needs regular monitoring to manage for invasive woody and weedy plants. Prescribed burns should be completed on over the entire park 3 to 6 years, with no more than half of the park burned in any given year.

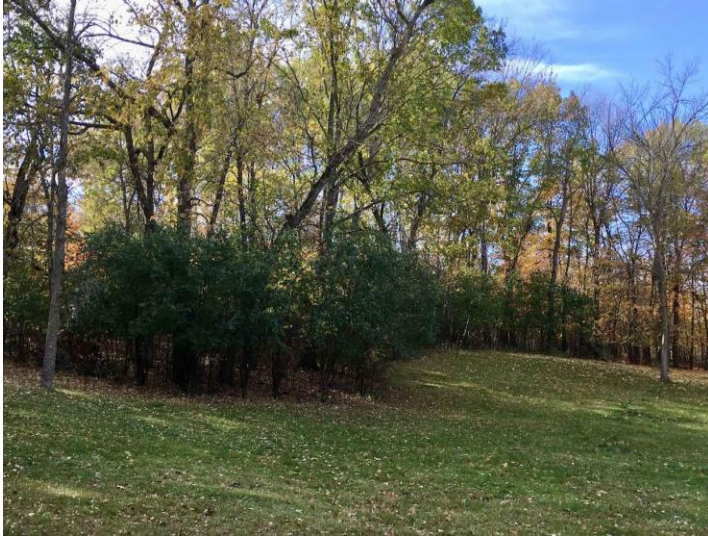
*Photo 14. Invasive shrubs dominate most of the wooded areas.*

About half of the property (44 acres) is forested, half of which is mixed deciduous/oak forest that is degraded by invasive woody plants, especially buckthorn (Photo 14) but also occasional black locust trees. Other forest acres include a couple acres each of maple-basswood forest, dry oak forest and mesic oak forest, 11 acres of floodplain forest, and five acres of hardwood swamp.

Invasive woody removal is the primary management needed in all the wooded acres, though it was most abundant in the degraded woods, with some large shrubs up to four-inches diameter. The floodplain forest had widely scattered but very large buckthorn, in the maple-basswood forest it was primarily along the trailside edge (Photo 15), and in the dry oak forest it dominated the ground layer up to two feet with a dense cover of small stems.

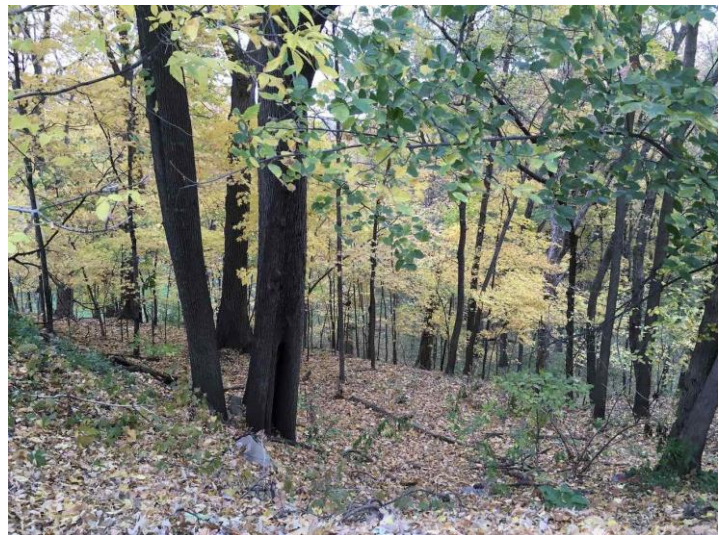
*Photo 15. Maple-basswood forest with few invasive species except along edges.*

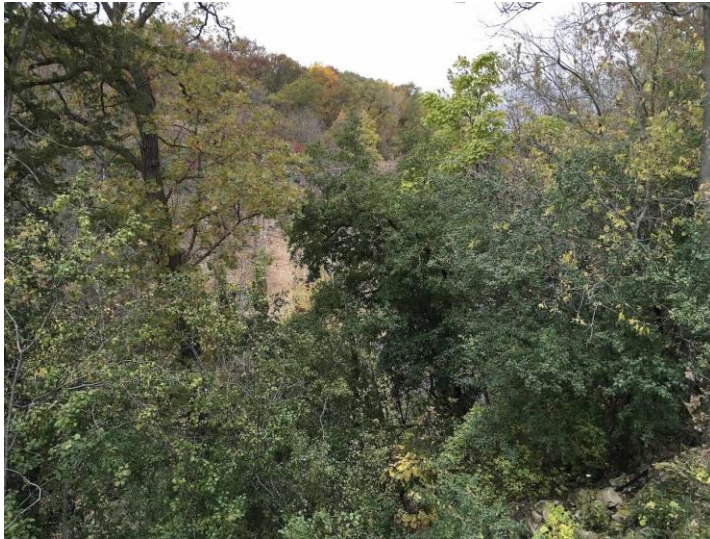
Along the river the buckthorn was very large, often obliterating the view of the river and the Old Mill Ruins on the other side (Photo 16). Much of the terrain there is quite steep and would require ropes and skilled experts to remove it.

*Photo 16. Buckthorn along the Vermillion River obscures views of the mill ruins.*

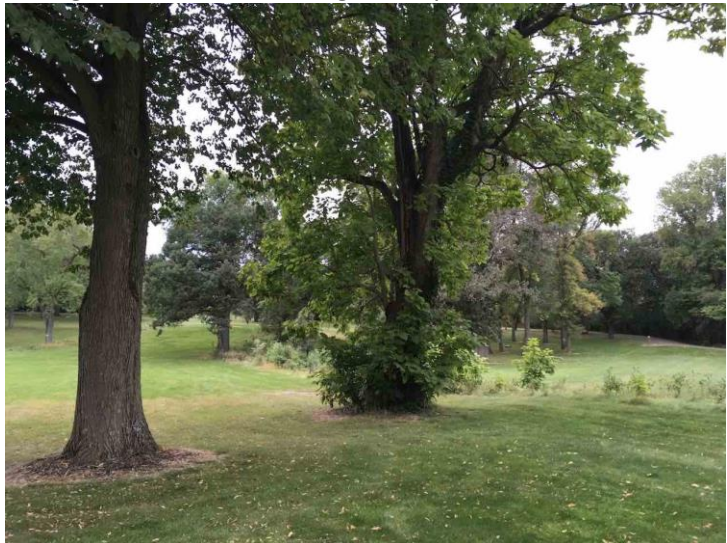
The **mowed grassland** has about a 50% tree canopy overall. The majority of the unit has scattered large trees in the turf area (Photo 17), but there are also narrow wooded corridors that serve to divide the disc golf fairways. Scattered tree species include red oak, bur oak (24" diameter at breast height, or dbh), cottonwood (up to 34" dbh), green ash (24-30" dbh), red cedar, basswood (32" dbh) and catalpa. Additional species in

*Photo 17. The disc golf course occupies much of the mowed turf areas of the park, with scattered individual and patches of trees.*

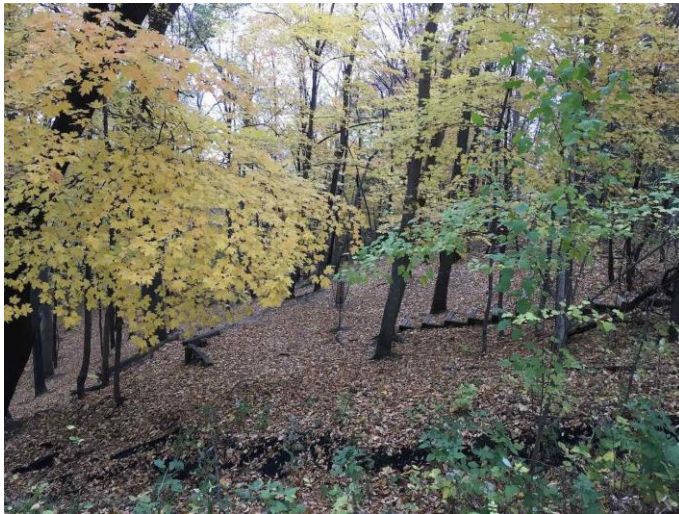
*Photo 18. The interior maple-basswood forest was largely devoid of invasive species.*

The 2-acre maple-basswood forest is largely intact (Photo 18), but there is abundant buckthorn along the top edge in places. This unit transitions to a 2-acre altered deciduous forest and both units are on a steep west to northwest slope.

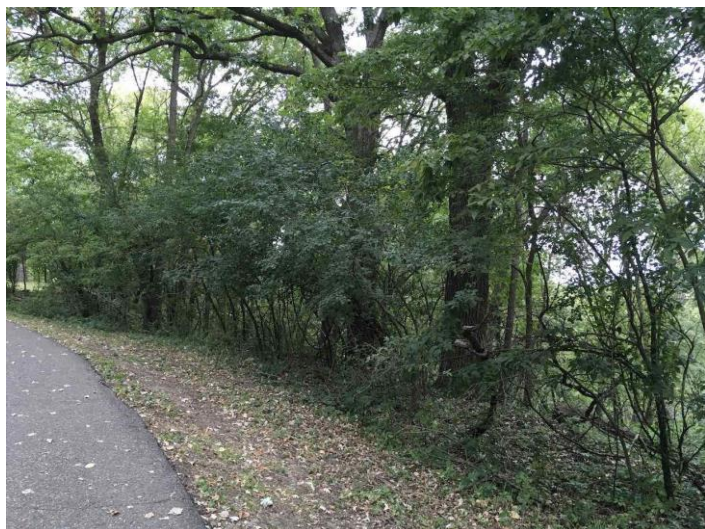
The altered woods harbors remnants of past uses, such as piles of rubble (fencing, concrete) and had some apparent soil disturbances. The canopy trees tended to be smaller diameter than other wooded areas, indicating these woods grew up more recently. Tree species include green ash, hackberry, cottonwood, basswood, and occasional small Siberian elm. Invasive shrubs are fairly low abundance but common along the edge (Photo 19). The ground layer is fairly beat up, with large areas unvegetated, possibly due to foot traffic. Creeping Charlie and burdock are abundant, but native species present included patches of wild ginger, zigzag goldenrod, clearweed, eastern woodland sedge, white snakeroot, and Virginia creeper.

*Photo 19. Buckthorn dominated the understory of altered woodlands.*

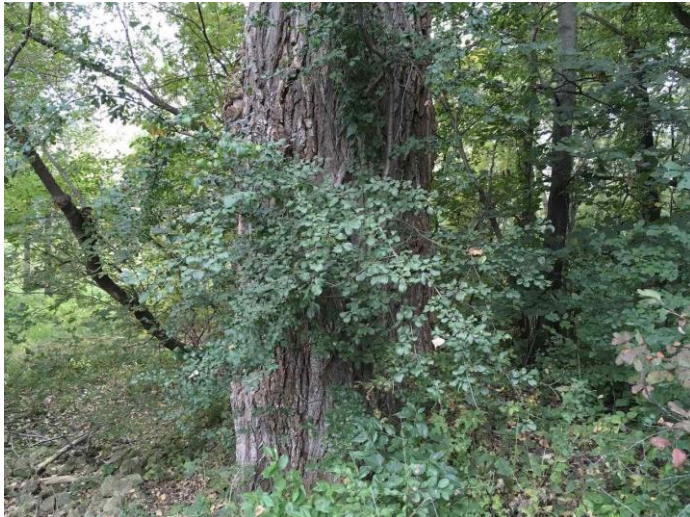
Photo 20. Several very large cottonwood trees were found in the floodplain forests. Invasive woody plants were most abundant along edges.

There are several floodplain forest units, totaling about 11 acres, which tend to have a dense tree canopy dominated by cottonwood (up to 3 feet or more dsh, including one enormous tree north of the bridge) (Photo 20) and silver maple (20-inch dsh) as well as basswood and green ash. The shrub layer is sparse but included patches of buckthorn, up to 3-inch dsh.

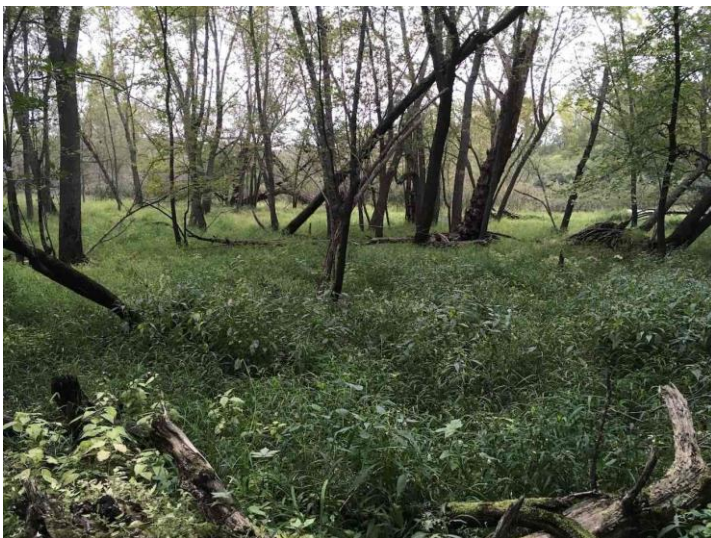
Photo 21. The hardwood swamp was mostly native species.

layer, and a ground cover dominated by rice cut grass, and abundance of *Bidens* spp., jewelweed (*Impatiens capensis*), and clearweed (*Pilea pumila*) (Photo 21). The emergent marsh was dominated by hybrid cattail (*Typha* spp.) There was also a stormwater wetland in the southeast corner of the grassland by the parking lot, composed of a variety of native wetland plants. The wetland units did not need any management.

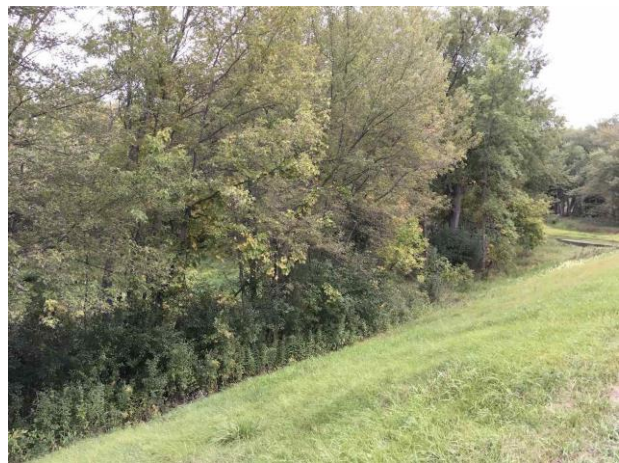
*Photo 22. Invasive woody plants were most common in lowland forests and roadsides.*

The parts of the SNA north of Ravenna trail are mostly emergent marsh, floodplain forest and open water. Silver maple dominates the floodplain forest, with green ash and small diameter American elm. These areas are largely devoid of invasive species except along the roadsides and edges (Photo 22), where buckthorn and honeysuckle have re-

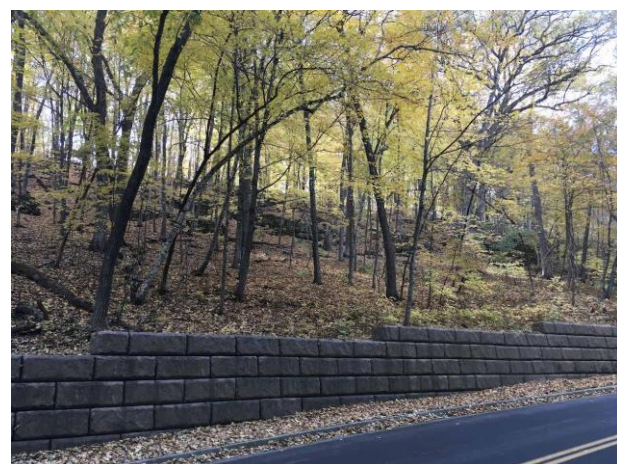
*Photo 23. The interior of the mesic oak forest was a largely intact native plant community.*

The southwest and southeast sections of the SNA are mostly mesic oak-basswood forest, with maple-basswood forest on the north-facing slope and wet ash (seepage) swamp and ponds at the base of the terraces. Old growth red oak, sugar maple, and basswood are found on the steep north-facing bluffs and bluff tops (Photo 23). Most of the SNA is ranked moderate to high biodiversity significance by the DNR.

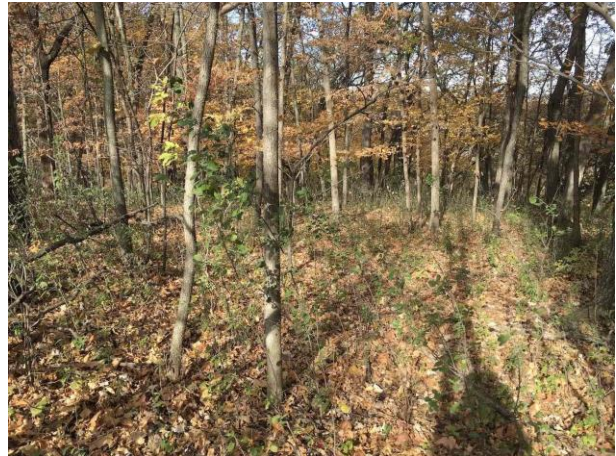
*Photo 24. Buckthorn seedlings were regenerating in previous removal areas of the south woods.*

Most of the native plant communities are relatively intact, but non-native invasive woody species are again encroaching in the woodlands (Photo 24). Buckthorn is the primary concern, and non-native honeysuckle was also present, primarily along roadsides and other edges. In addition to the roadsides, small buckthorn was fairly abundant in the southeast section, occupying several acres east of the Veteran's Home property. The shrubs present are generally small - seedling to six feet tall - and up to one-inch diameter.

Invasive woody control is the top priority management need at the SNA. To provide maximum protection to native plants, the method of buckthorn control should only be cut and stump-treated (with dauber applicators). Foliar application should not be done. Very small plants will not get treated, so a repeat cut-and-treat will be needed in five or six years to address plants that have matured to a larger size.

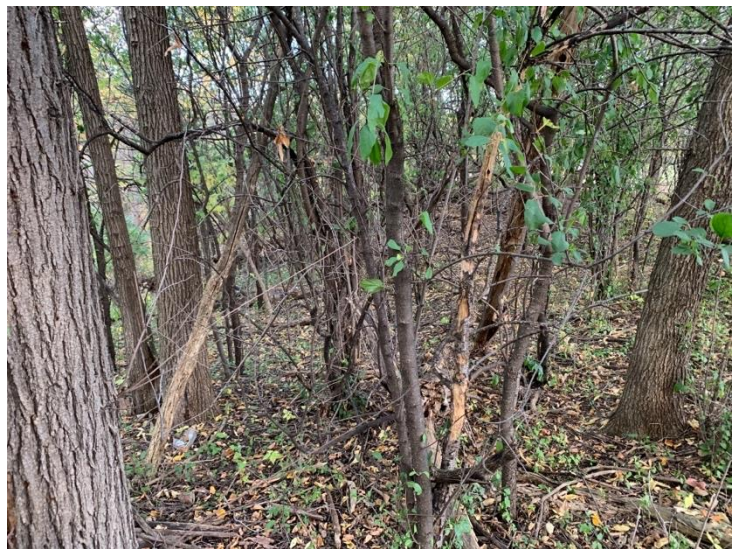
*Photo 25. Woodland at Rivertown Dog Park*

The eastern end of the woodland has a higher density of buckthorn (Photo 25), and these plants are mature and senescing. The canopy trees in the eastern woodland include red and pin oak, black walnut, American basswood, and green ash. Some regeneration of these native species is present, but the understory is largely dominated by buckthorn.

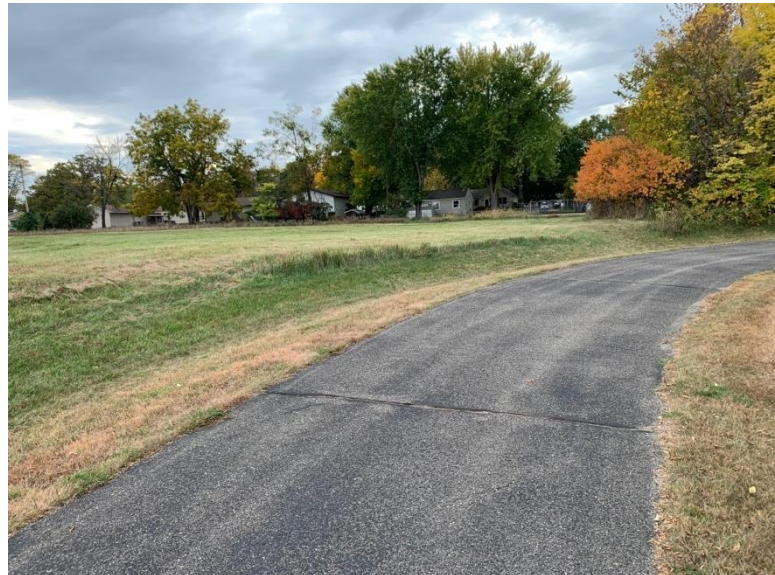
*Photo 26. Corridor between Rivertown Dog Park and Downtown Hastings*

The greenway section between the Rivertown Dog Park and the parks along the Mississippi River is a narrow corridor of trail along Ravenna Trail which connects through the neighborhoods south of downtown. The trail edges are primarily mowed turf (Photo 26) and have been planted with swamp white oak in sections. The trail's crossing of the Smead property skirts the edge of a possible remnant prairie that has been degraded by invasive species such as spotted knapweed and Siberian elm. The trail's alignment through the neighborhoods west of Lake Isabelle follows the edge of the Canadian Pacific railyard, and the vegetation quality is very poor owing to the degree of disturbance. Yard waste dumping has introduced day lilies and snapdragons through this area of the corridor, and a large stormsewer outfall between 5<sup>th</sup> and 6<sup>th</sup> Streets on Bailly Street has created a deep gully between the railroad tracks and the trail.

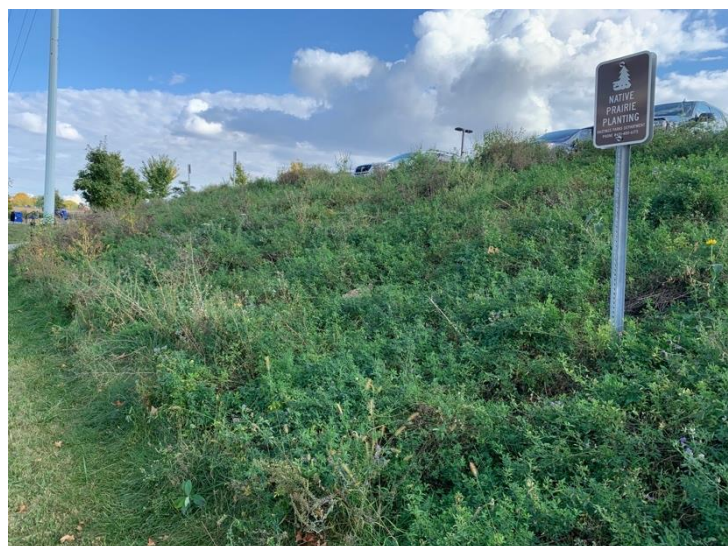
*Photo 27. Levee Park prairie restoration project.*

downstream of the railroad bridge. A native prairie planting on the slope between the Rotary Club Pavilion and the parking lot east of Sibley Street was initiated but is weedy with common ragweed, alfalfa, and turf grasses (Photo 27). Little tree cover is present, and the hillside is in nearly full sun. At Jaycee Park, large areas of mowed turf are also present, but the trail corridor is somewhat screened from roadways by trees and shrubs.

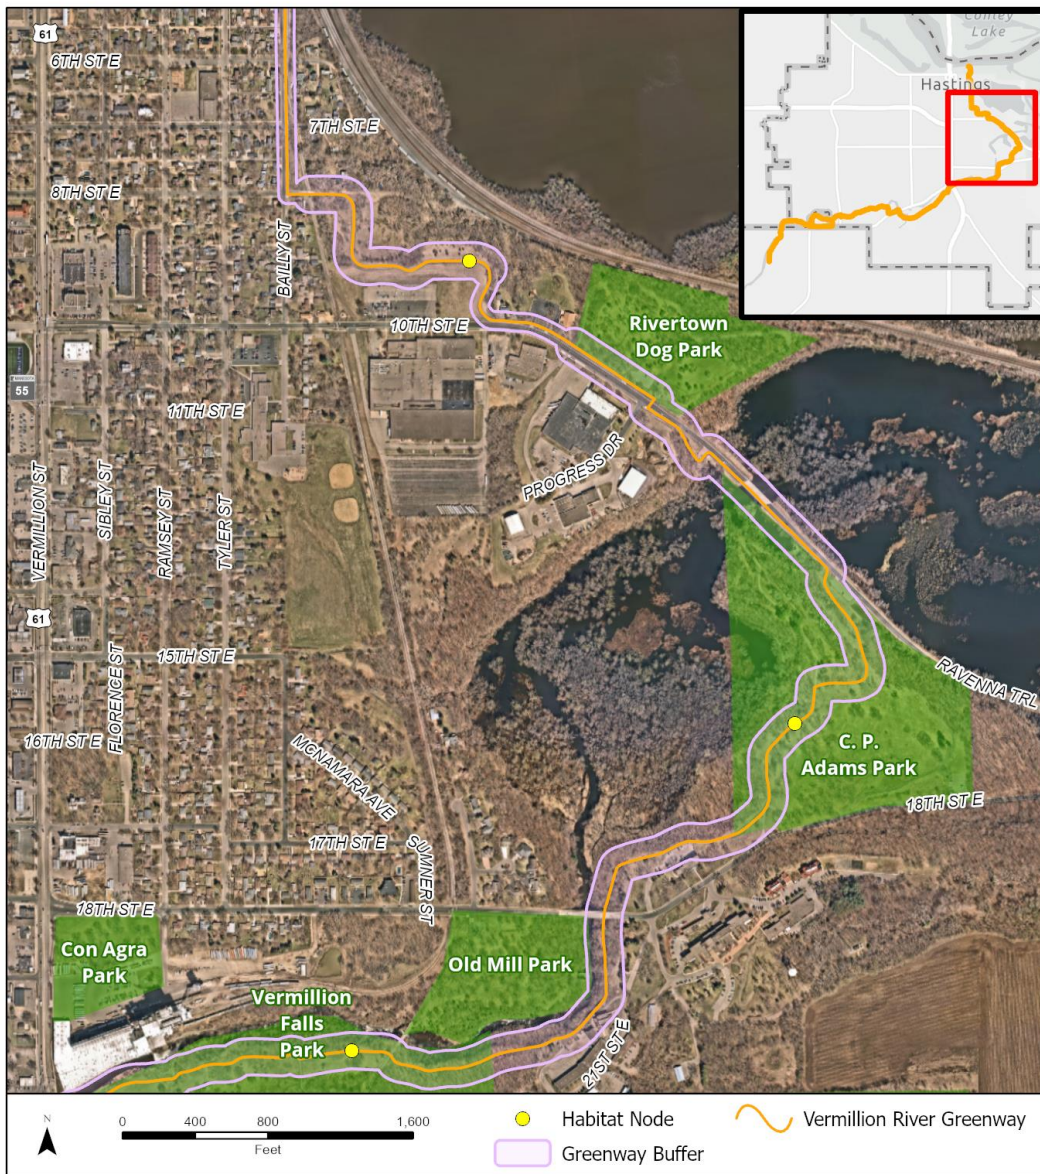
**Figure 35. Greenway corridor schematic showing the Vermillion Greenway, Hastings Segment. The northern part of the segment will consist of a 100-foot, urban greenway corridor, and the southern part, starting at the Rivertown Dog Park will consist of a 300-foot, rural greenway corridor, with the portion between them consisting of a mix of urban (100-foot), rural (300-foot) and suburban (200-foot)**
