North Creek Greenway

Natural Resources Management Plan

8/18/2022

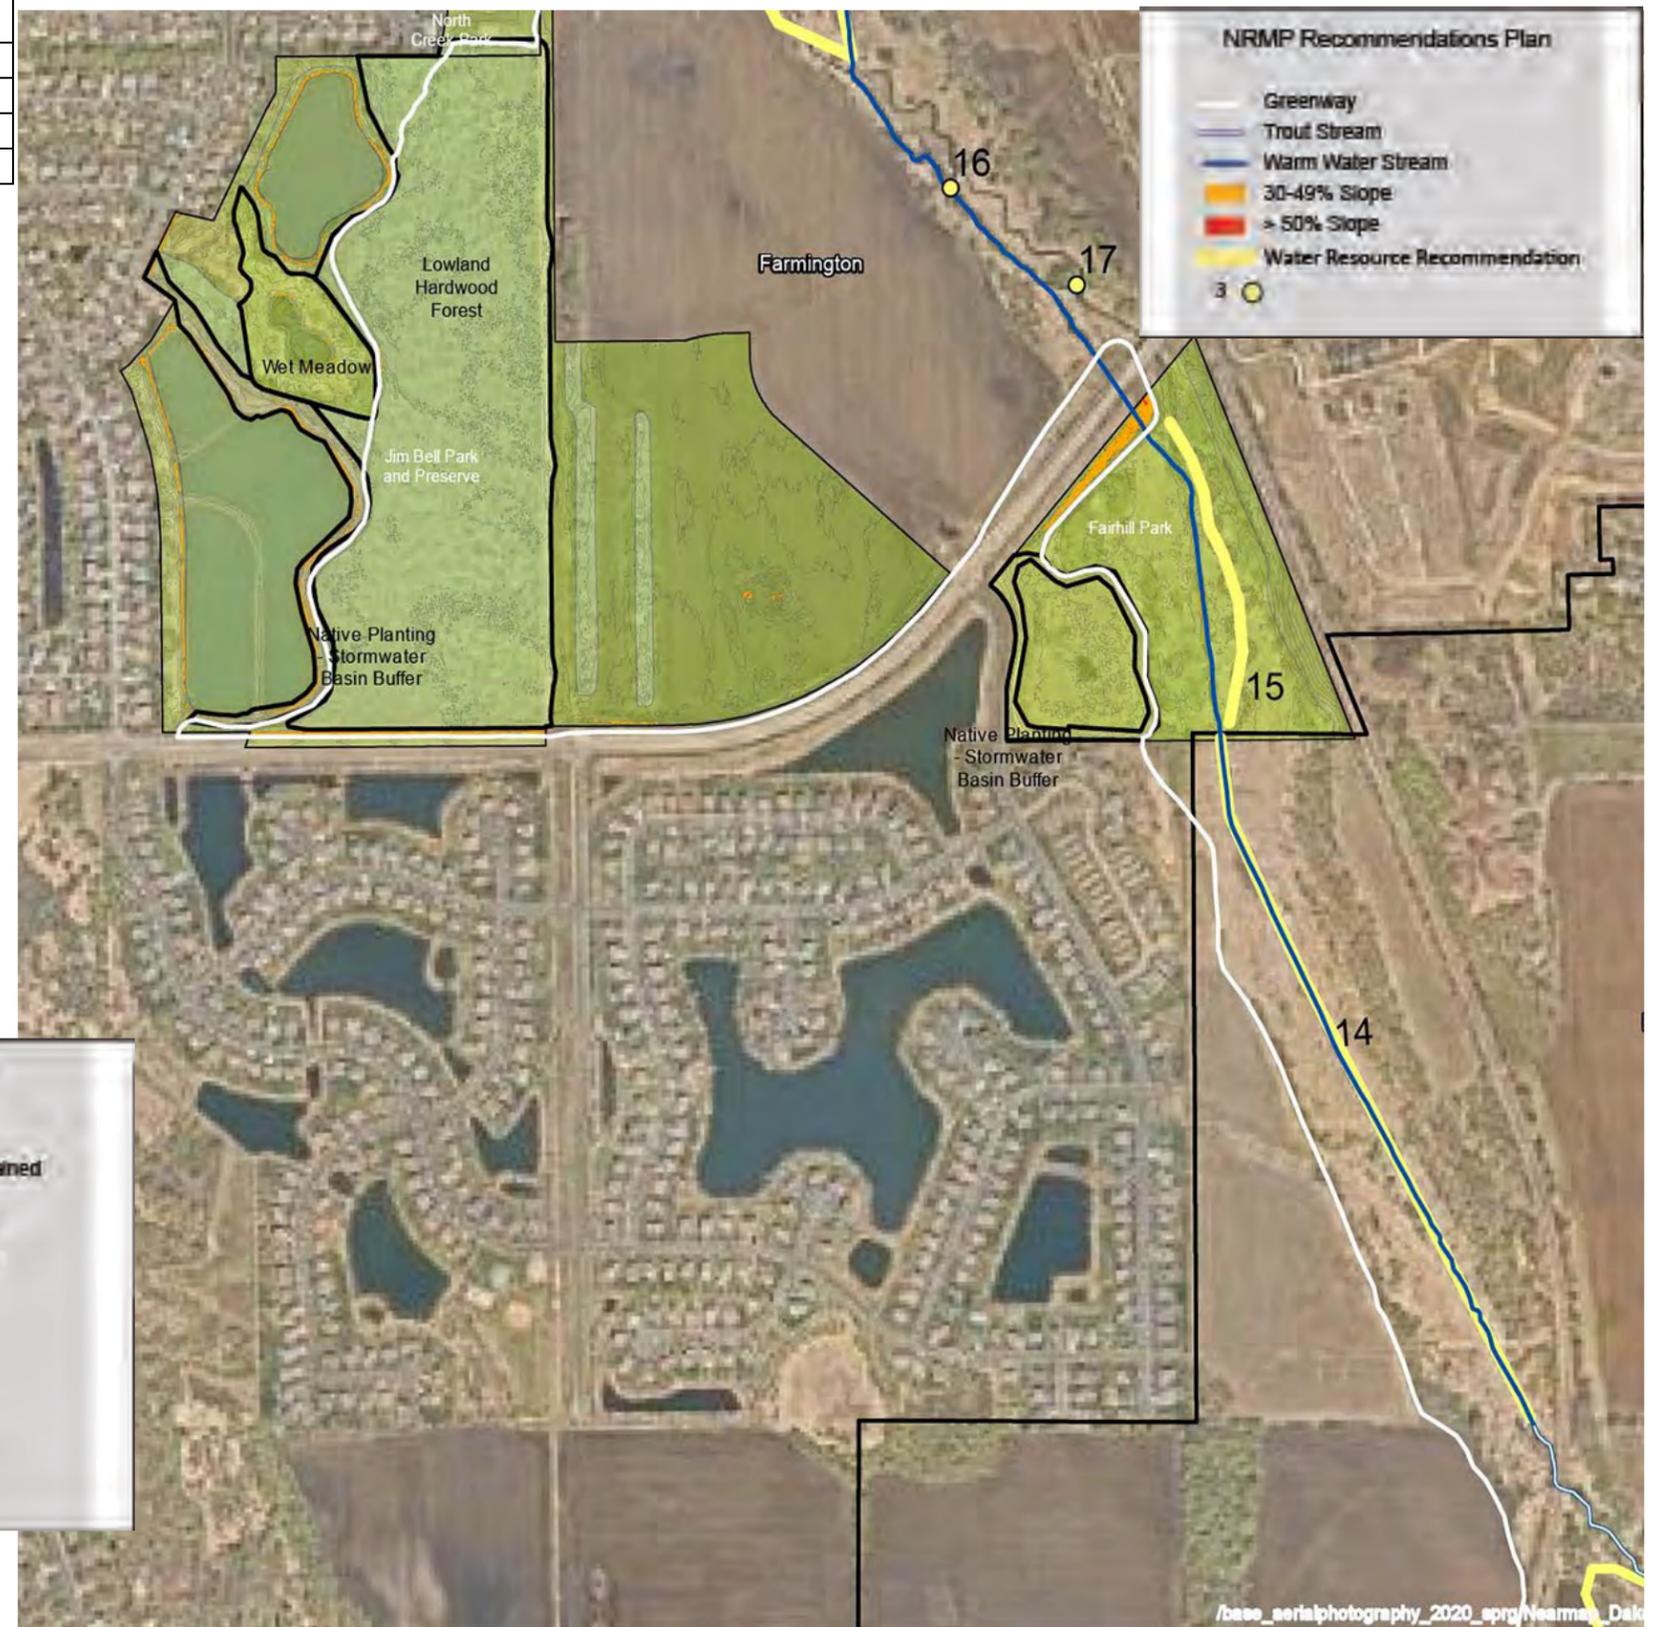
Figure 14B North Creek Greenway, Farmington: Jim Bell Park – Fairhill Park – North Creek

Priority features for restoration and management include wet meadow, lowland hardwood forest, and native buffers around stormwater basins. Native buffers are recommended for stormwater features at both Jim Bell Park and Preserve and Fairhill Park.

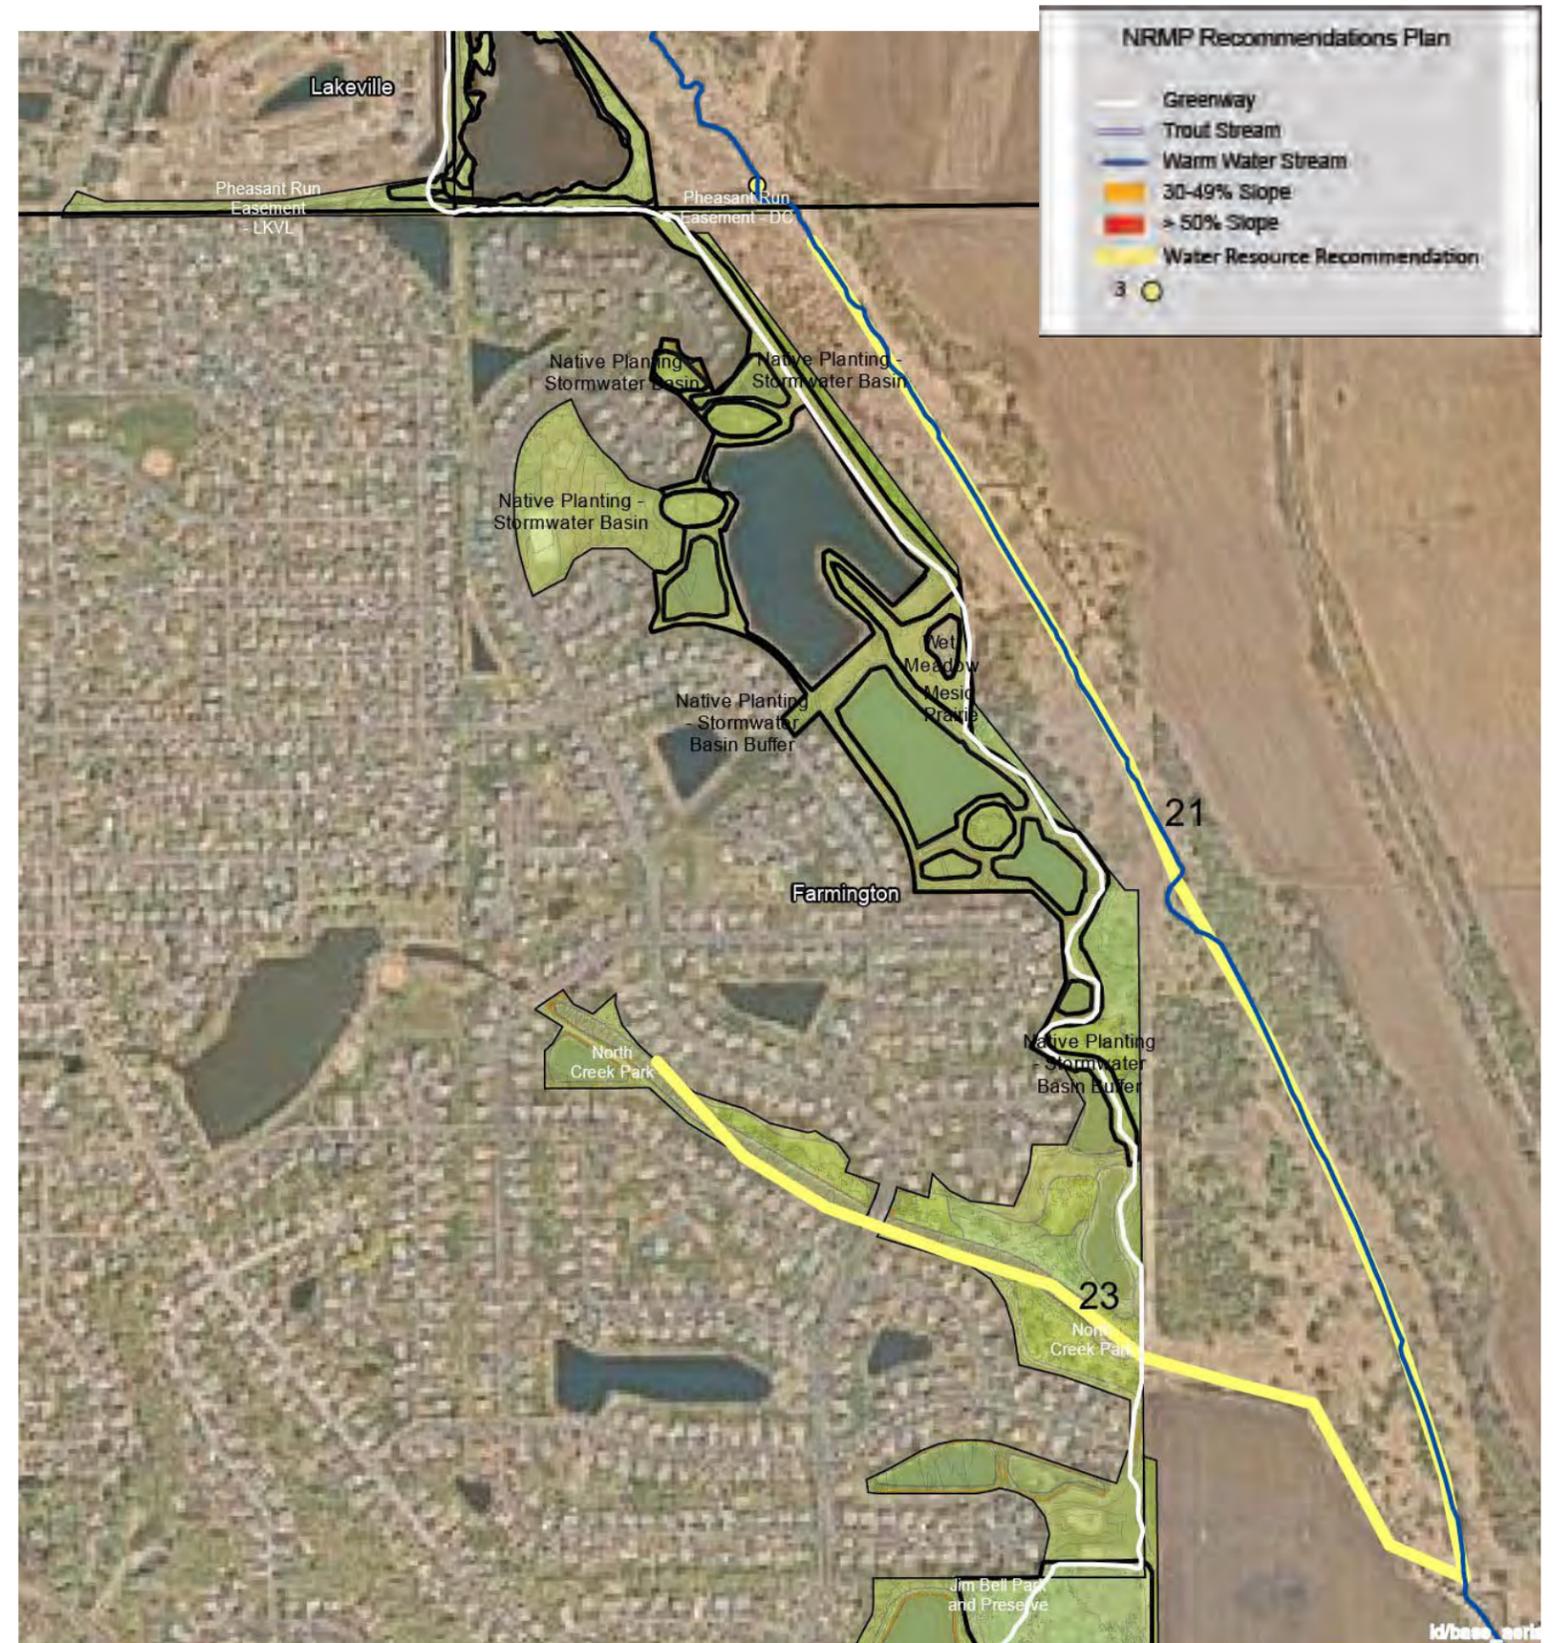
Figure 14C North Creek Greenway, Farmington: North Creek Park – North Creek – North Creek Tributary

Water Resource Recommendation	Description
21	In-stream habitat, meandering, additional shading on North Creek
23	Additional shading on North Creek

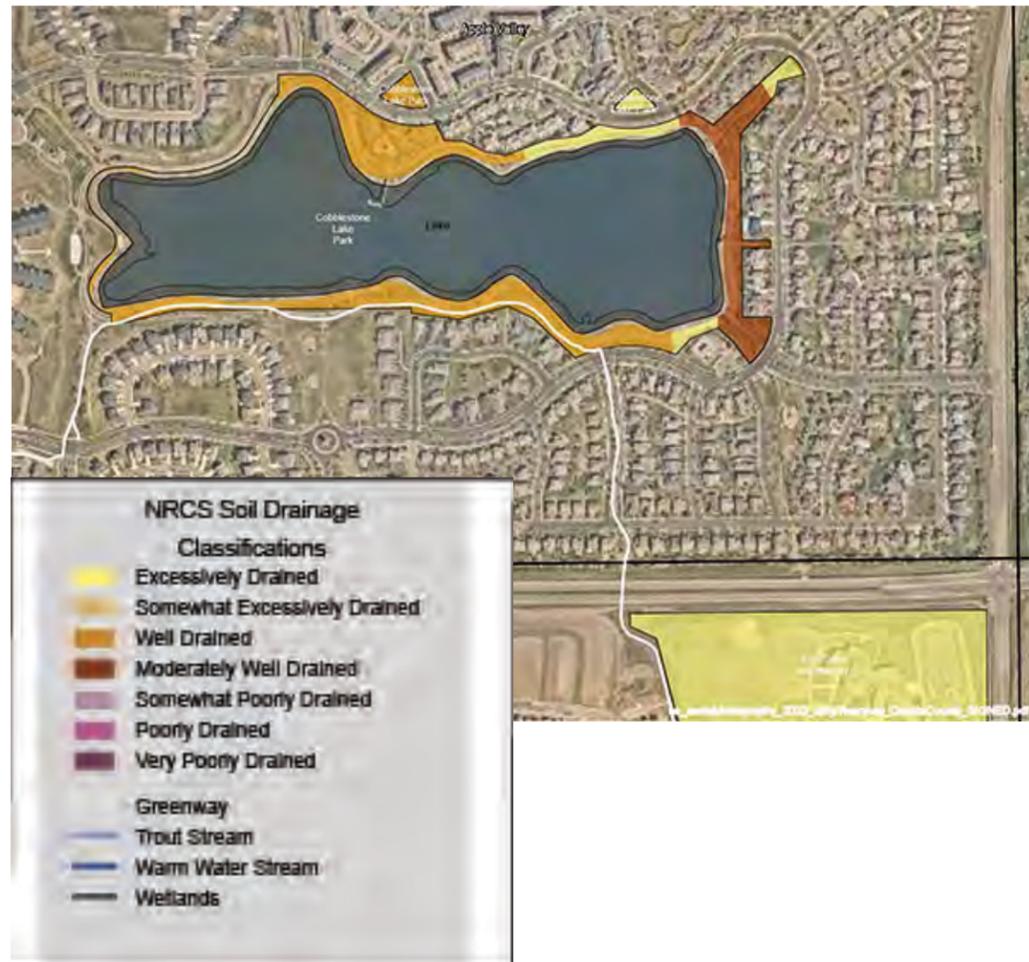
Figure 14F North Creek Greenway, Apple Valley: Cobblestone Lake Park

Priority features for restoration and management include native shoreline buffer plantings and a rain garden planting.
