# Vermillion River Greenway-Hastings Segment

Natural Resource Management Plan

2023

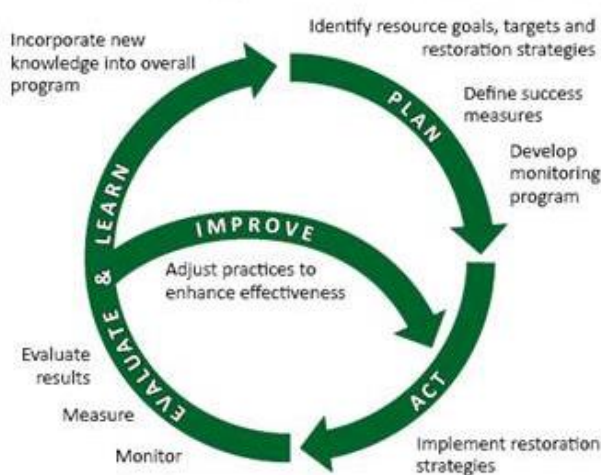
Figure 3. Adaptive Management Approach Schematic

The overarching goal is to return and maintain a diverse native plant community within a site, though this will not always follow a linear progression. Using the concept of adaptive management will be the key to continual progress. Adaptive management integrates thought and action into the restoration process and can be described as a process that uses evaluation, reflection, and communication to incorporate learning and responsiveness into planning and management.

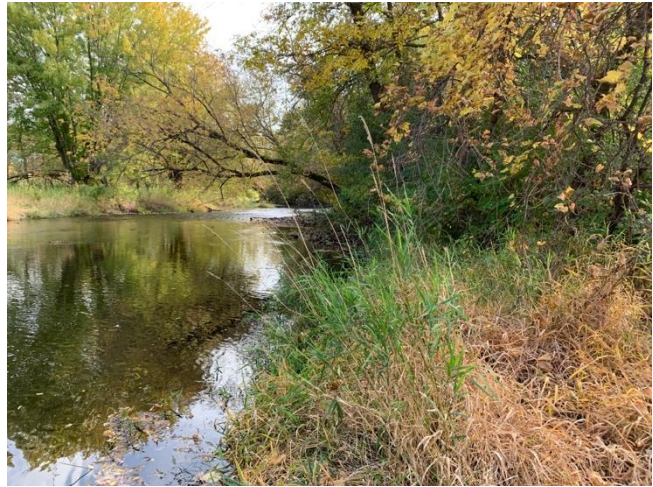
The 4-acre parcel at the northwest corner of General Sieben Drive and 160th Street East is owned by the City of Hastings and has approximately 385 feet of frontage on the Vermillion River. The MLCCS cover types are listed as long grasses on upland soils in the upland areas and altered/non-native deciduous woodland along the river. The upland is a fallow field in recent production, and the stream corridor is forested and dominated by bur oak, green ash, eastern cottonwood, and box elder (Photo 1). The shrub layer is dominated by common buckthorn, but some oak regeneration is present in canopy gaps. Smooth brome has moved from the upland/old field area into the perimeter of the woodland. The open character of the parcel indicates that it could be easily converted to oak savanna or native prairie, if canopy thinning were to take place. The trail is essentially staying along the same centerline but increasing in width from 10 to 12 feet west of the trestle bridge.

Photo 1. Riparian area near General Sieben Drive

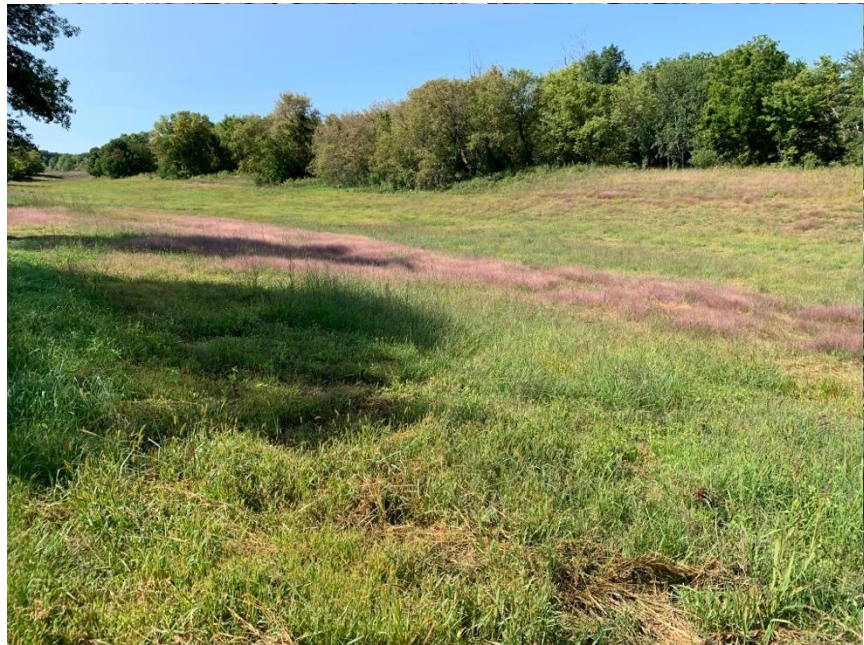
This 60-acre park is a long, linear property managed by the City of Hastings. In coordination with Friends of the Mississippi River (FMR), three phases of restoration have been undertaken on the property following priorities of a natural resources management plan developed by FMR ecologists in 2012. These priorities include restoration of the riverbanks, managing invasive species, and establishing native plant communities appropriate for the present-day hydrology of

Photo 7. Spillway at Vermillion River Linear Park

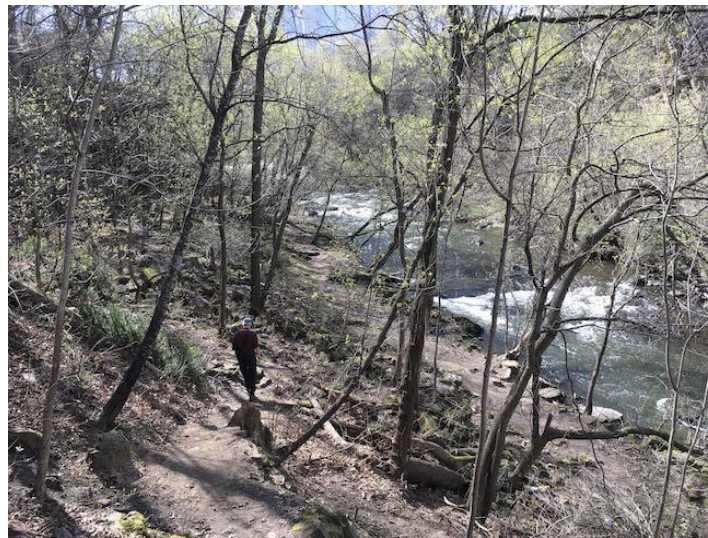
Friends of the Mississippi River completed a Natural Resource Management Plan for the park in 2019 and has been implementing habitat restoration activities at 20 acres of the park since then to restore oak forest, maple-basswood forest, and oak savanna.

*Photo 9. Maple-basswood forest after invasive woody removal. Note the formation of unofficial trails.*

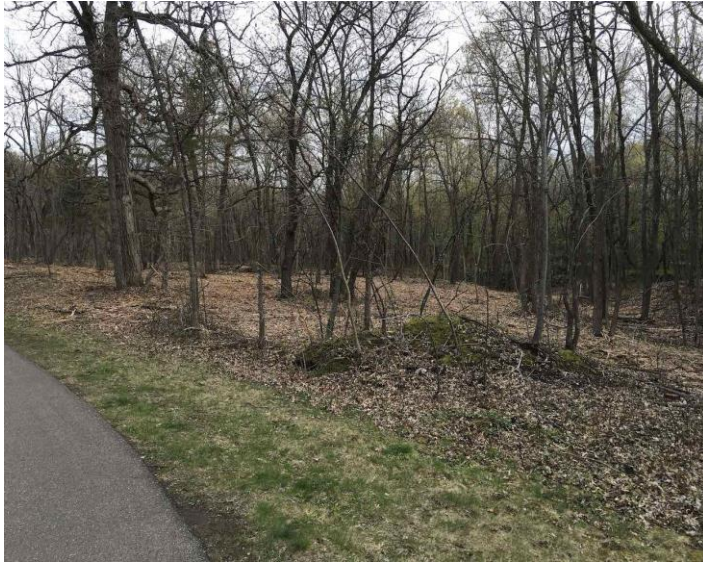
*Photo 10. Degraded woodland after forestry mowing to restore native plant community.*

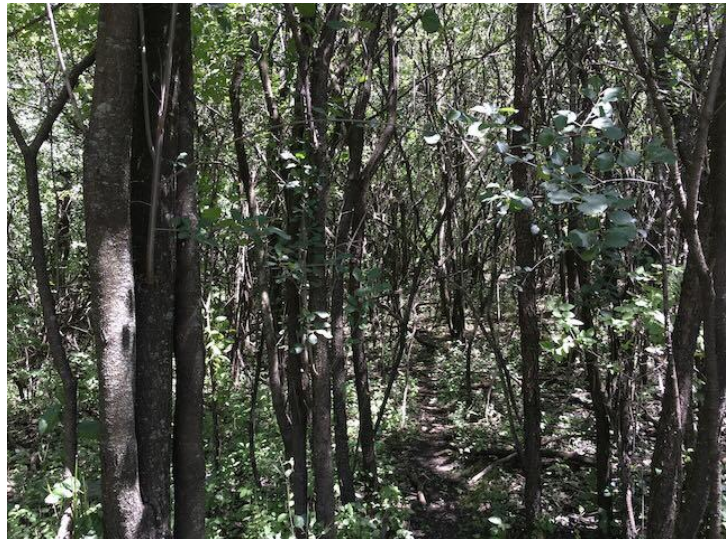
*Photo 11. Very degraded woodland prior to restoration.*

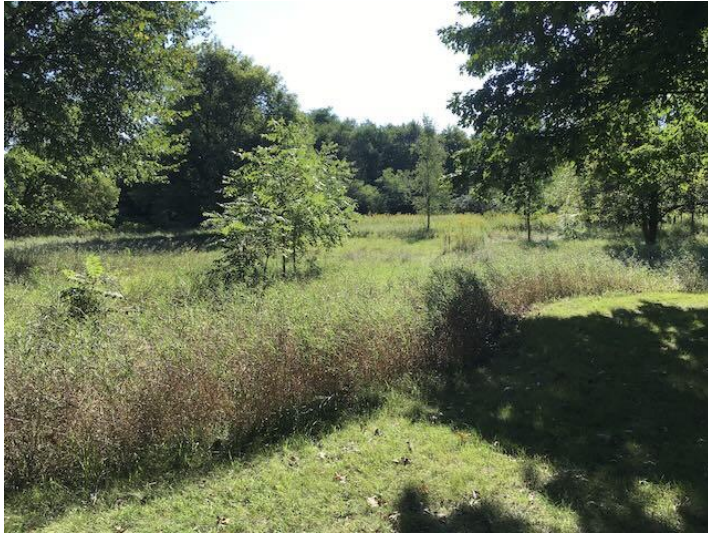
Photo 12. Non-native grassland before restoration to savanna.

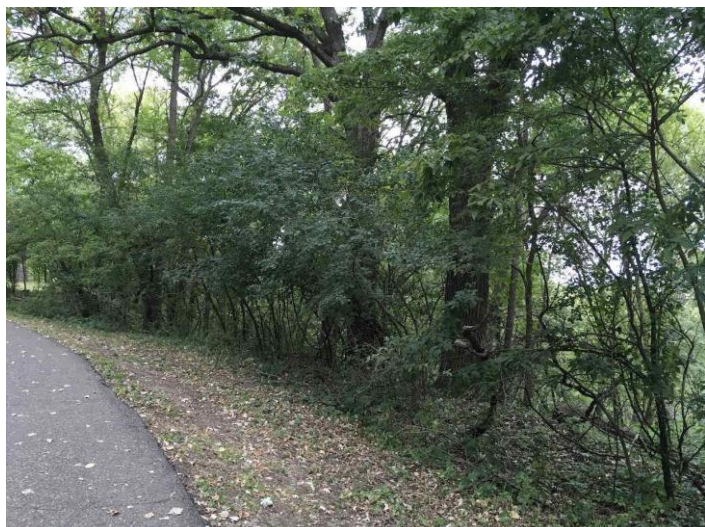
*Photo 19. Buckthorn dominated the understory of altered woodlands.*
