## Lake Marion Greenway

Natural Resource Management Plan

06/16/2022

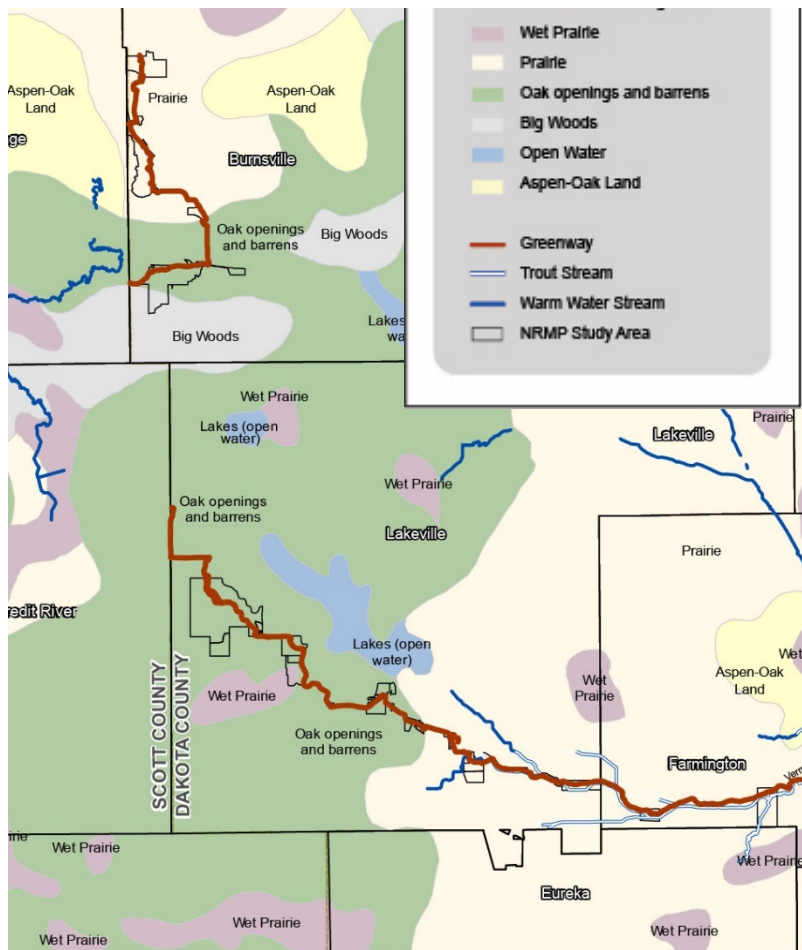
Figure 4 Pre-settlement Vegetation of Greenway Corridor and Surrounding Region

As shown in **Figure 4**, the pre-settlement vegetation patterns of the Greenway Corridor were highly variable. The southern arm of the Corridor through Farmington and the eastern half of Lakeville was predominantly oak openings and barrens. North of the Burnsville / Lakeville municipal boundary, areas with Big Woods, wet prairie and prairie were mapped.

The Oak Savanna subsection of the Corridor, in the Lakeville and Farmington area, historically consisted largely of gently rolling hills with bur oak savanna being the primary vegetation community, but with areas of tallgrass prairie and maple-basswood forest also being common. The bur oak savanna consisted primarily of mesic to dry tallgrass prairie with an occasional and interspersed canopy of fire-resistant trees such as bur oaks.

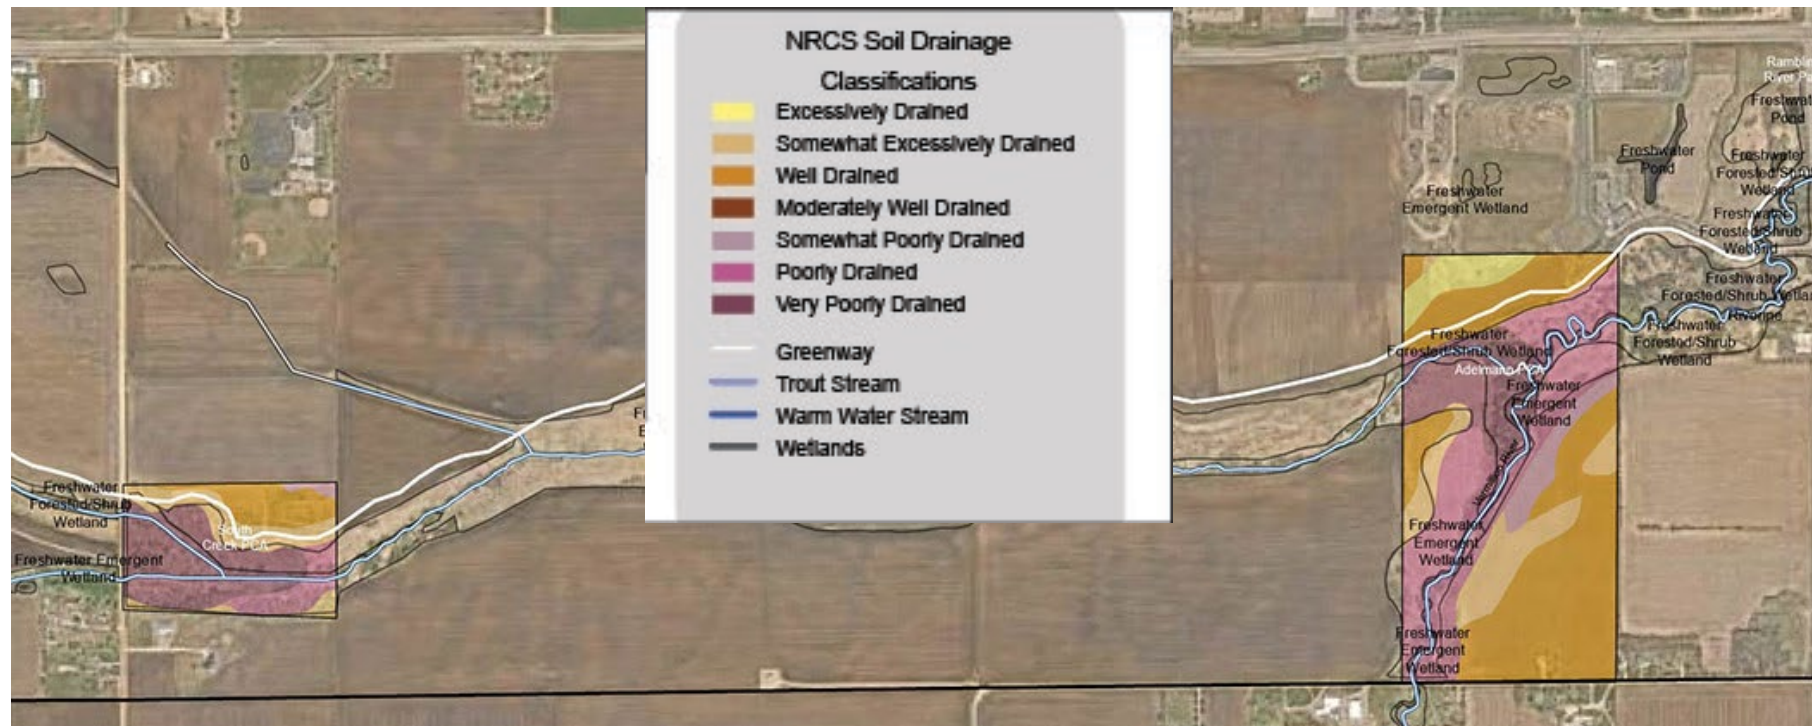
South Creek PCA

Water Resource Recommendation	Description
3	In-Stream habitat improvements, meandering on South Creek
4	Study potential for wetland restoration at confluence of South Creek and tributary
5	Address erosion near trail crossing at Vermillion River
11	Maintain in-stream features recently constructed on South Creek
